**ABLE INSPECTIONS**  
*Inspecting Commercial  
 Steel buildings Since 1976*  
**713 465-0000**

**PROPERTY INSPECTED:**

NI	NP	D	INSPECTION ITEM	
	●	○	○	<b><u>Foundation &amp; Structural System</u></b>	**

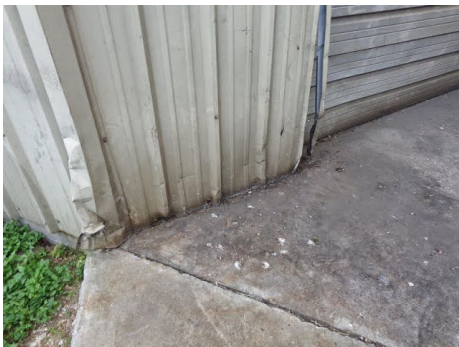
**Damaged exterior siding and trim**

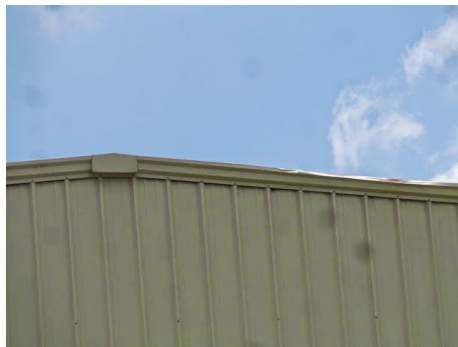
**Damaged upper north edge of roof**

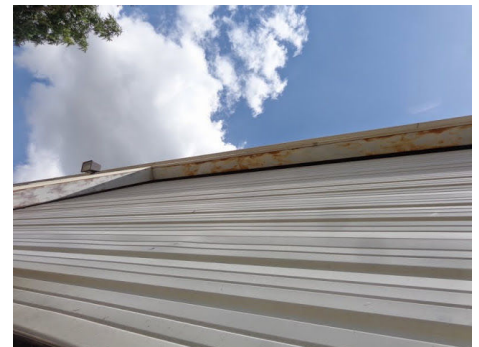
**Rusted trim on bay doors**

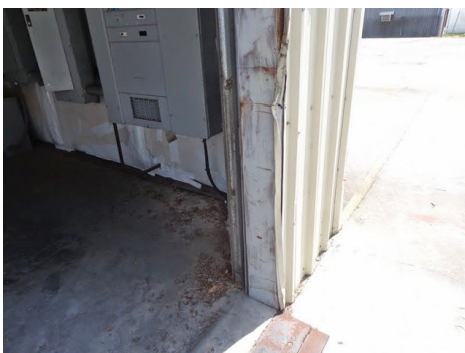
**Damaged side panels on bay door**

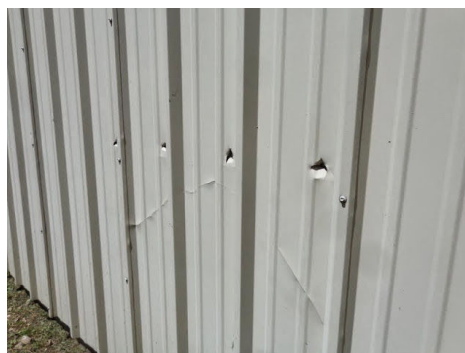
**Holes in siding**

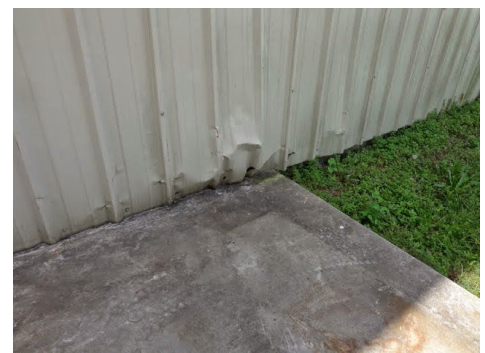
**Damaged lower siding**

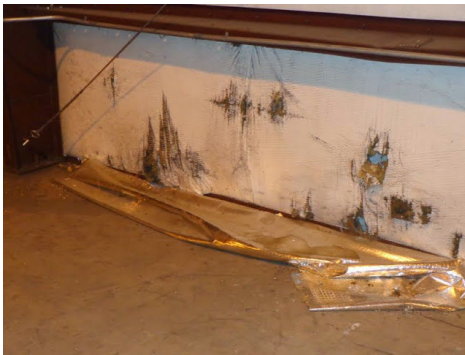
**Stained and damaged interior wall insulation**

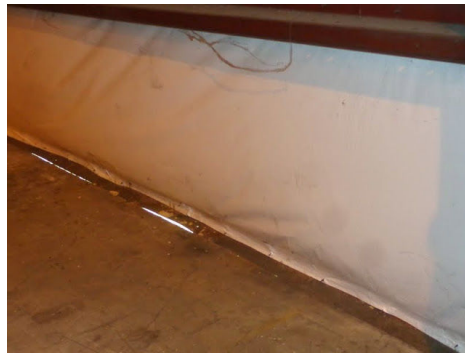
14. Daylight along lower outer edges.

**Daylight along lower outer edges**

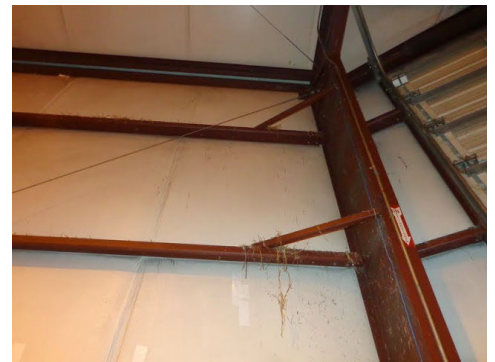
**Bird nesting inside building**

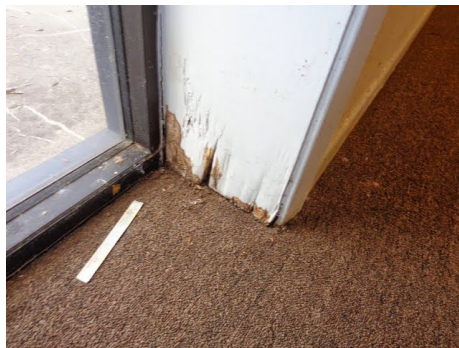
**Damages inside office**

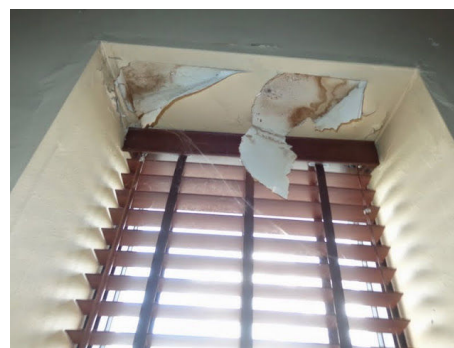
**Damages inside office window**

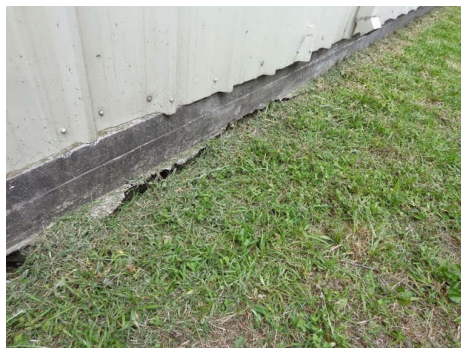
There are multiple rain gutters that terminate within close proximity of the building and foundation system which has resulted into erosion and loss of soils especially noted at east and west areas of commercial steel building, therefore all rain gutters should be extended away from this foundation system and/or installed into underground storm drain piping system.

**Erosion at northeast area**

We recommend that the buyer retain the services of a reputable and qualified landscaping and drainage expert to investigate the area around this commercial steel building. They should provide specific recommendations on the installation of possible drain and water movement systems as well as make suggestions on improving the grading techniques to reduce the collection of rainwater and thereby reduce the possibility of water intrusion into this commercial steel building and to minimize erosion with proper water diversion control methodology

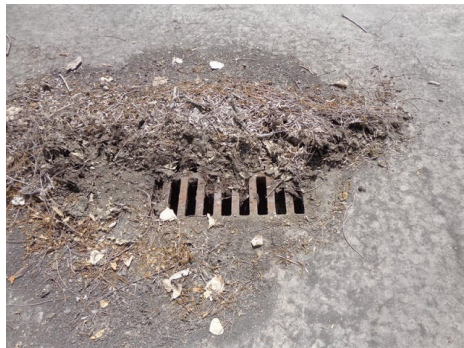
**Clogged east drain in parking lot**

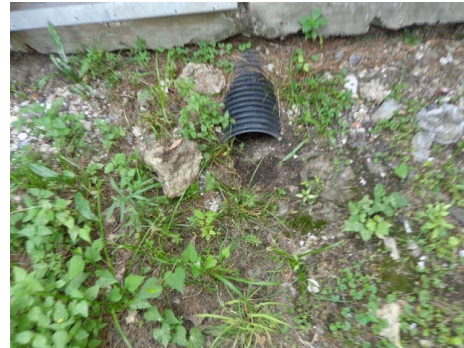
**Clogged drain at west side**

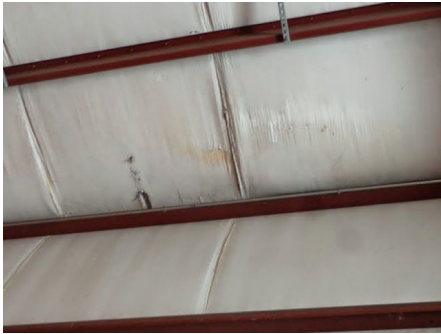
**Stained insulation under roof**

**Therefore, due to multiple suspect locations of roof leakages located in offices and warehouse, we suggest consulting with reputable fabricated metal roofing contractors in immediate future for their examination of this roof and for their opinions and recommendation and proposals for repairs and any possible replacement materials.**

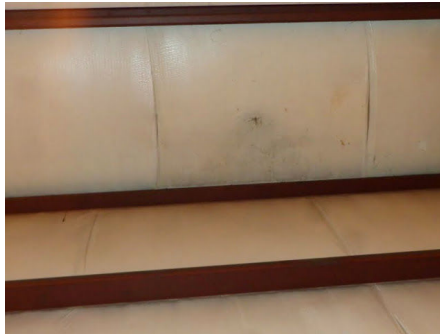
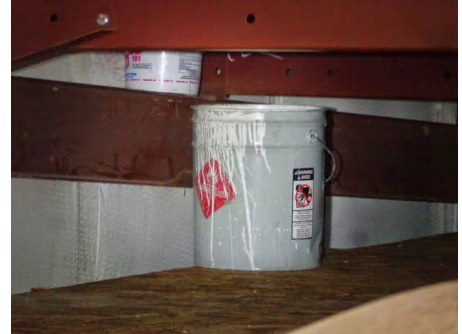
**Buckets in attic**

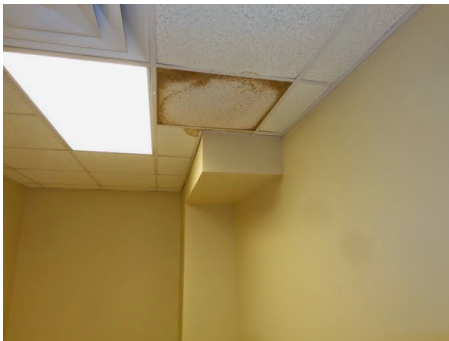
**Ceiling tile damages**

It is very important that a prudent buyer retain the services of a reputable and qualified contractor in the immediate future to determine the exact source of leaks, to examine all areas for hidden damages and to expose any possible mold/mildew and provide estimates for the appropriate repairs. Failure to respond to the conditions mentioned above, before the purchase of this property, commonly results in unanticipated, and often costly, repairs.

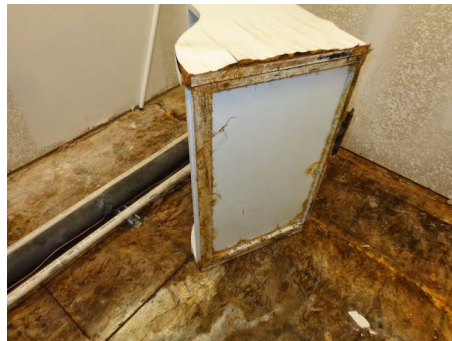
Significant staining in HVAC equipment room on floor, ceiling and wall associated with roof and HVAC type leakages – not raining during inspection and HVAC equipment has been sabotaged by copper thieves, therefore could not operate equipment during our inspection process.

**Stained floor and cabinet in second level equipment room**

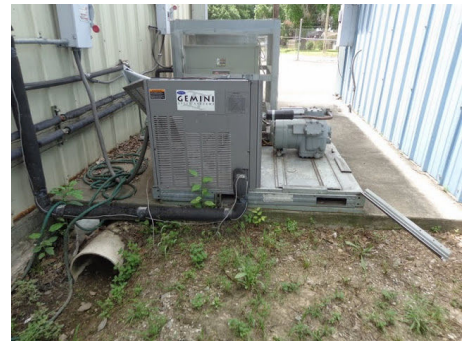
**Both large A/C units vandalized**

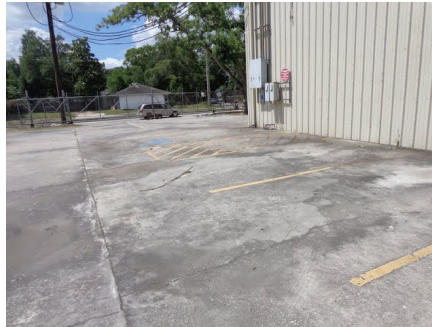
**Worn paint markings for parking**

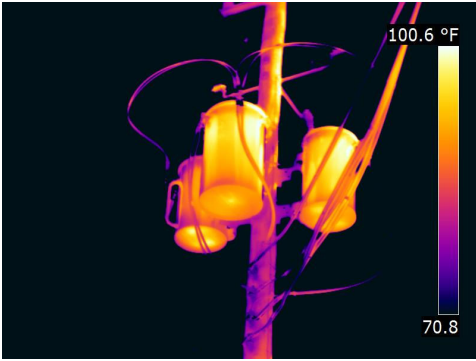
Image taken of electric transformers

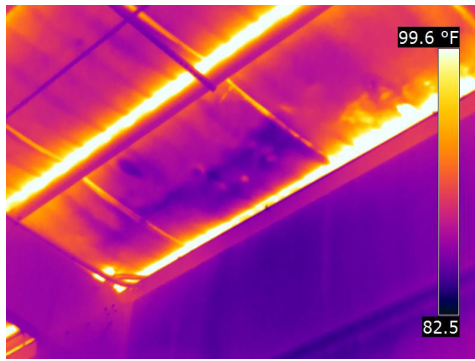
Typical heat on metal roof frame and moisture images on insulation under roof

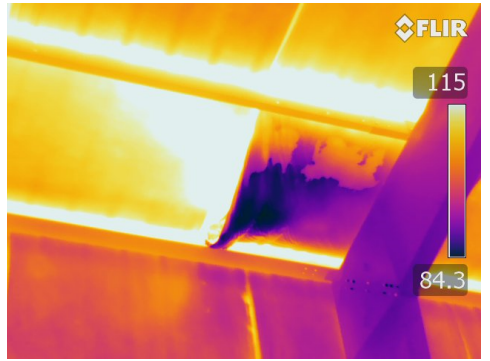
Moisture trapped in insulation under roof

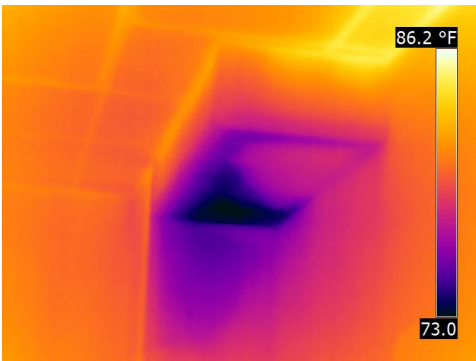
Image of moisture in upper office from roof leakage

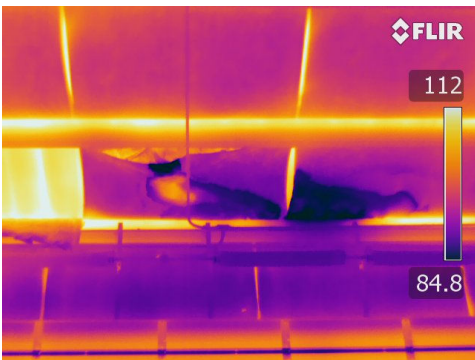
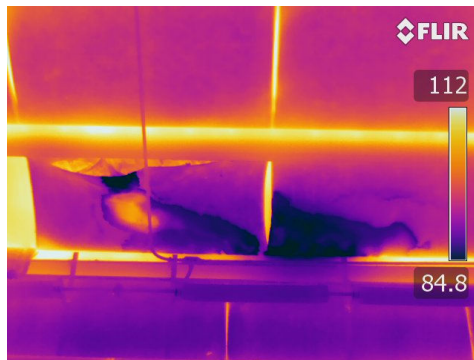
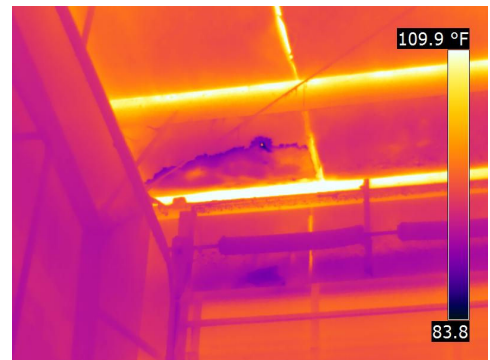
Images of moisture from active roof leakages on insulation

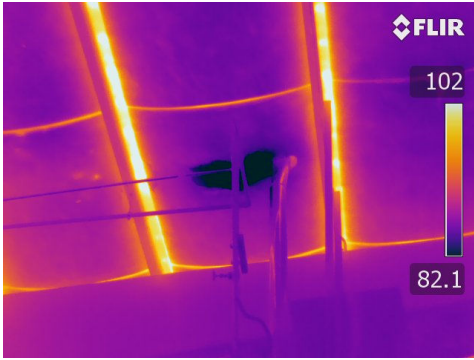
Moisture from active roof leakages

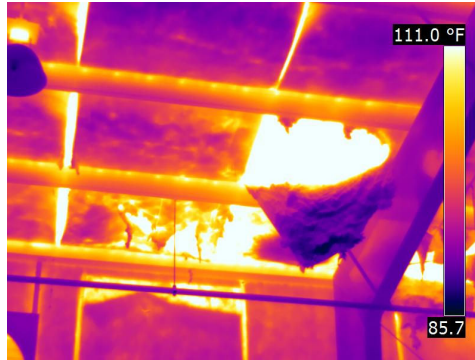
Images of heat on insulation from compromised insulation

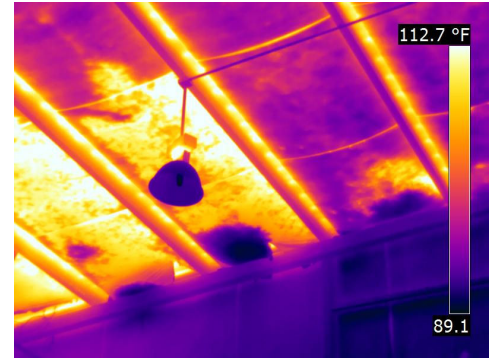
Blue images represent moisture along edges on interior roof

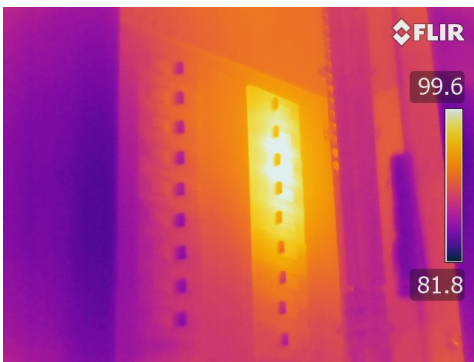
Heat on interior breaker panel breakers during operation of equipment

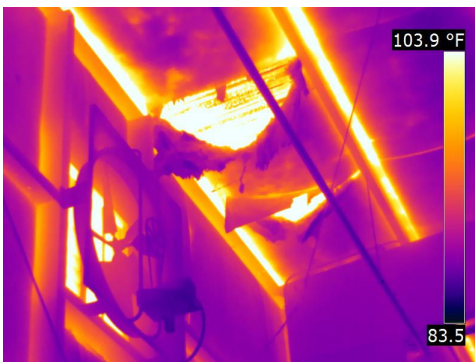
Image of torn insulation under roof

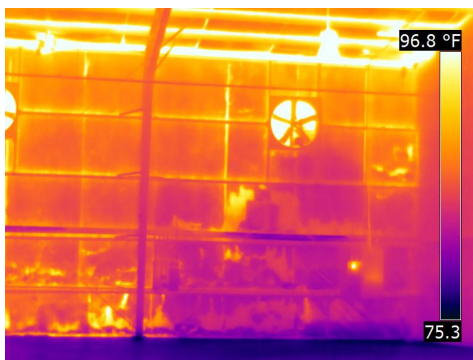
Images of compromised insulation on interior building walls

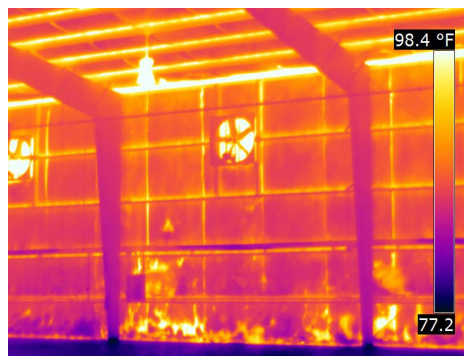
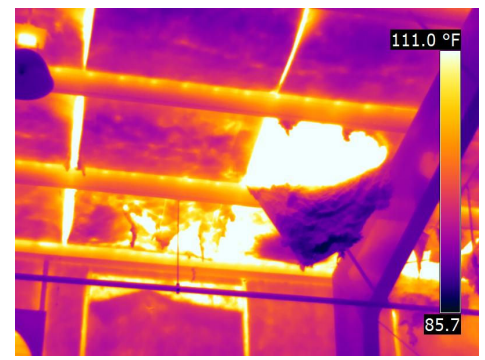
Torn and damaged insulation under roof
