ABLE INSPECTIONS
Inspecting Office buildings
 Since 1976
 713 465-0000

PROPERTY INSPECTED:

INSPECTOR: Larry Malloy TREC 332

OFFICE BUILDING DESCRIPTION w/ATTACHED FRONT AND REAR ENTRY COVER

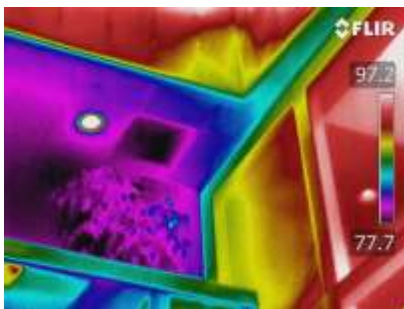
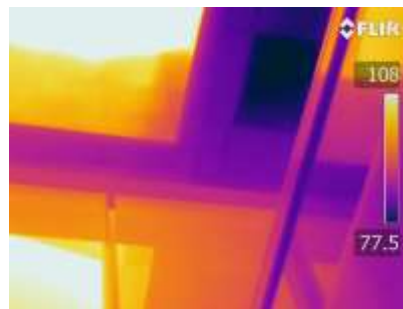
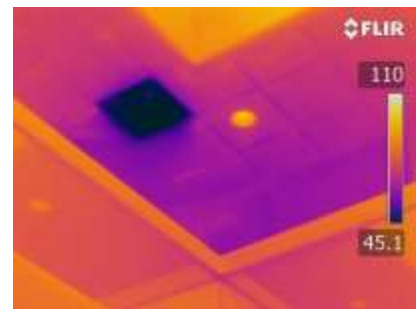
No anomalies located on upper stained ceiling tiles from skylight projection

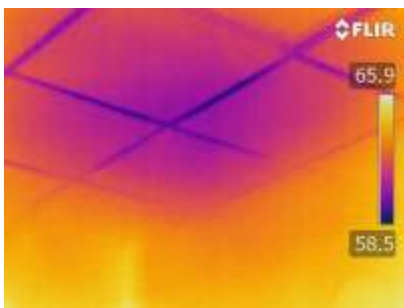
No anomalies at stained kitchen acoustic tiles

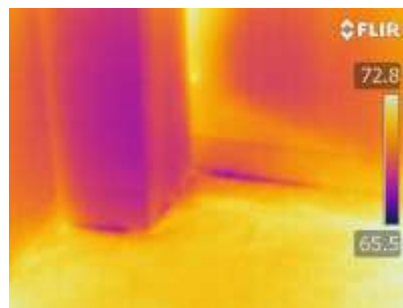
Small areas of moisture at base of front northeast base and carpet

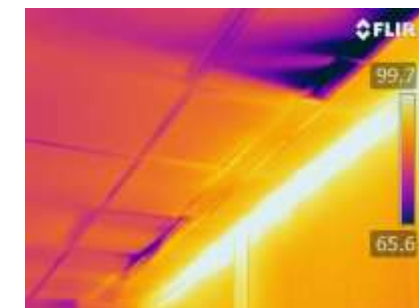
Image of quality air supply at right slotted air register and limited at left register in upper south office

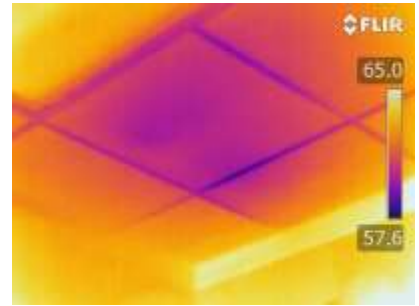
No anomalies on stained acoustic tiles in upper southeast office

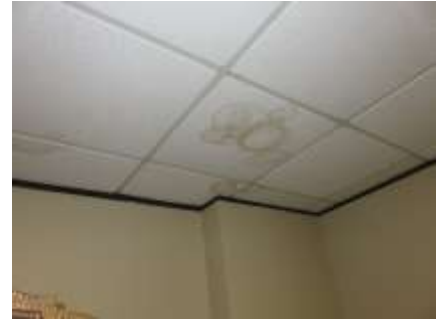
First level east kitchen acoustic tile stains

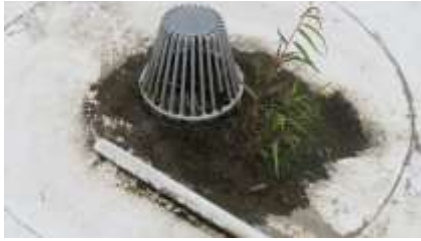
Debris and vegetation at roof drain from HVAC drain

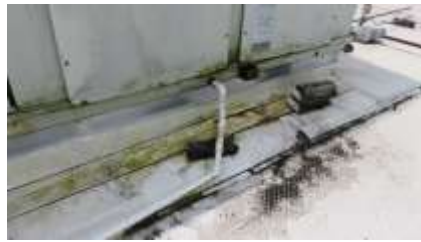
Excess stains and water off HVAC equipment on roof

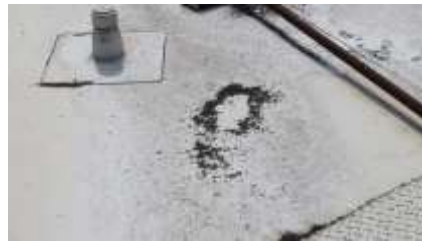
Debris on roof from ponding water

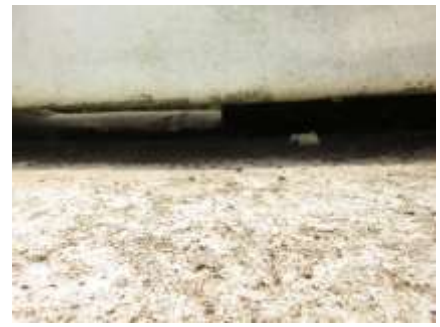
8. Narrow drain scuppers along south side of building with debris accumulation in need of excavation and thorough cleaning which has resulted into significant staining to the exterior brick cladding material and these scuppers can be modified with additional extensions of flashing material to minimize further staining of this brick, etc.

Debris at south drain scupper

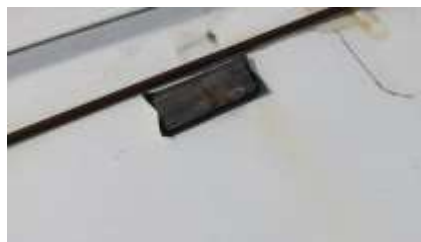
11. Several locations of worn, compromised and missing wood blocks supporting rusted metal conduit for the HVAC systems and exterior lighting and these areas can be examined by appropriate contractors for replacement and priming and repainting of the rusted conduit.

Loose 2x4 supporting conduit

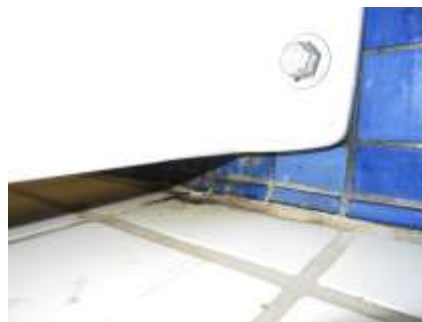
Leaks off toilets

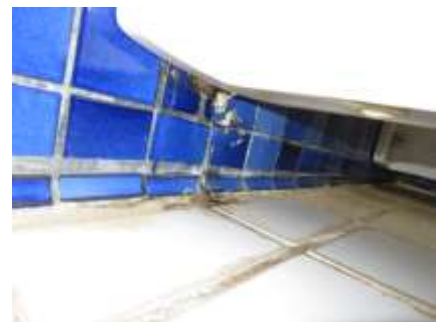
Leakages of toilet

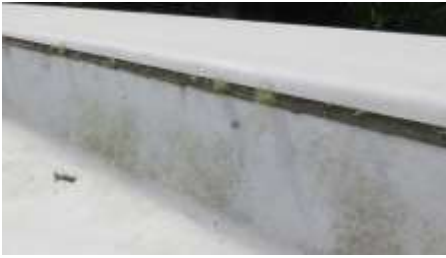
4. Vegetation growth located along edges of roof and parapet wall/flashing along southeast area of roof.
5. Vibration noted on roof during operation of HVAC unit (especially near older Trane equipment).

Plant growth along southeast roof

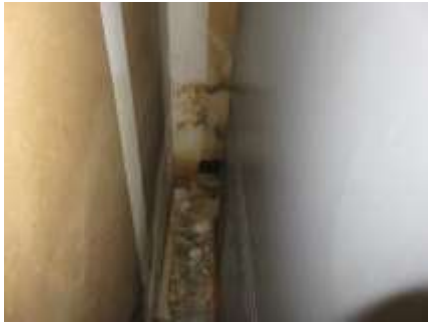
1. Damaged sheetrock with stains, mold and mildew at rear southeast elevator equipment closet from leaks that had occurred at one time off of P trap above – this sheetrock material is in need of immediate removal and further examination can be performed for air quality from this compromised wall material with mold/mildew propagation.

Sheetrock damages and mold

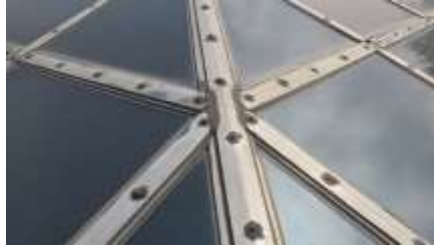
Sealant repair

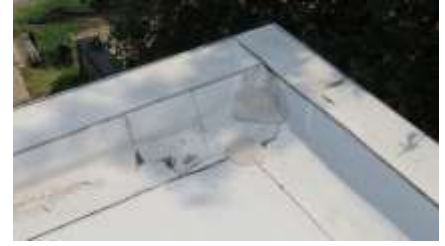
6. Random patch repairs located to this roof system from leaks that may have occurred at one time.
7. Tar and other sealant repairs located along edges of main skylight projection and on glazing and framing members from leaks that have occurred to this projection (not raining at time of inspection to locate any signs of active leaks, however, staining exists inside of this skylight glazing, faming and acoustic tile areas as viewed from in foyer.

Repairs to roof

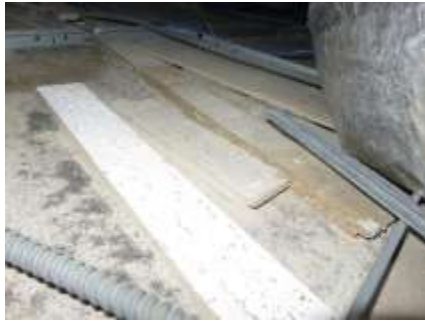
Stained acoustic tiles and mold/mildew

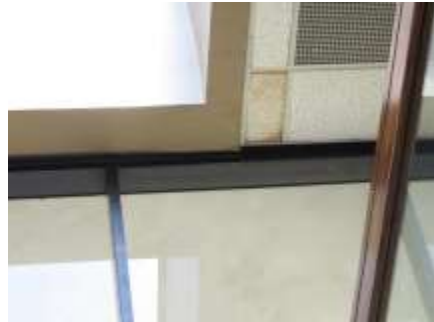
Stained acoustic tile off skylight

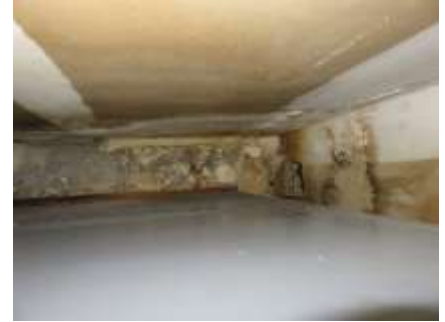
Sheetrock wall damages and mold

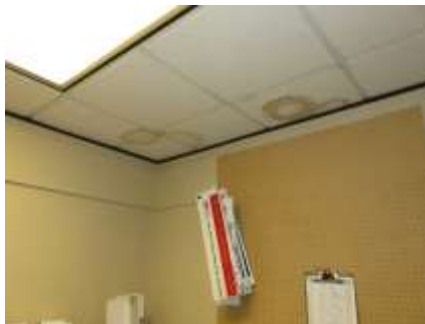
Stained tiles in upper west storage closet

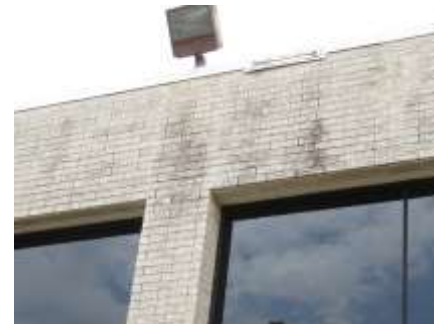
3. Significant staining of exterior brick especially at rear south of building from drain scuppers off of roof system.
4. Some rust on metal lintels at window openings with brick support at front, rear and side locations.

Stained brick off roof scuppers

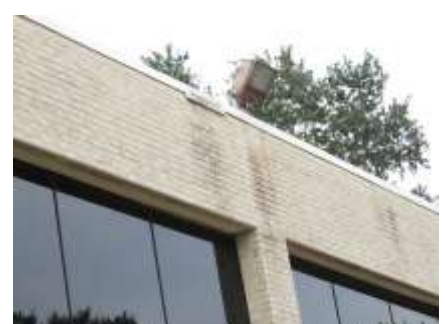
Stained brick

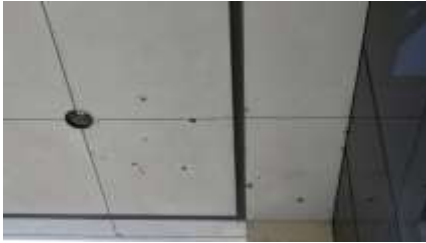
Stains and mud wasps on stucco ceiling at front exterior

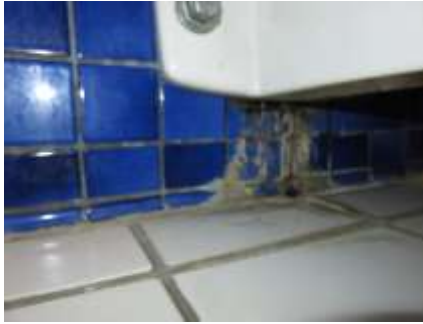
Stains and leakage off toilets

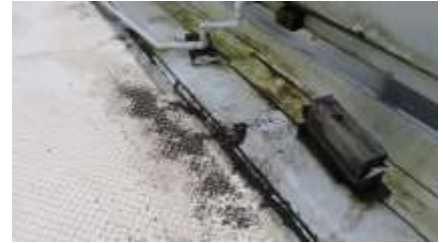
Stains and debris off HVAC on roof

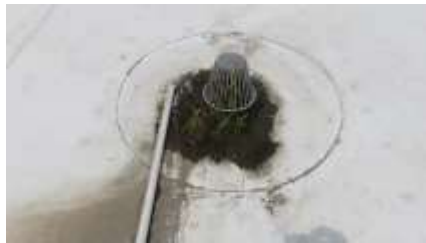
CONDENSATE DRAIN: (D) Loose piping off both units and not piped directly into roof drain system metal cages. Missing proper trap off Trane unit. These drains should also be cleared and flushed with Spring and Summer season operation.

A/C drain not installed into roof drain

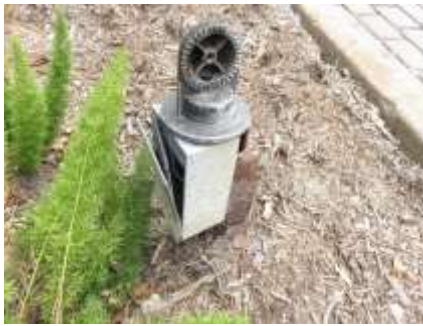
Broken junction box at front exterior sign

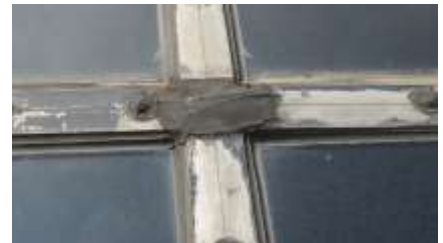
There is a large metal frame and glass skylight projecting thru front north roof which has been repaired multiple times with roof tar cement and other sealants due to leakages. It was not raining during our inspection therefore we could not address whether this projection leaks. Suggest consulting with Building Owner and or Building Maintenance Co for all information of repairs made to this opening.

Tar sealant on skylight

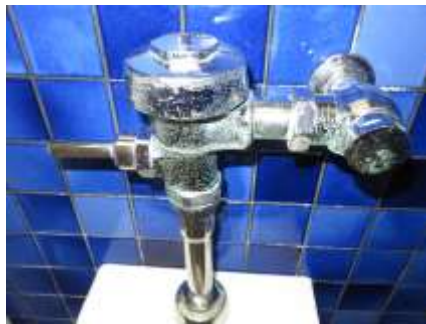
Corrosion on men's urinal fixture

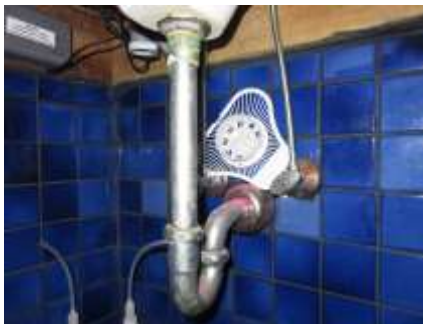
Corrosion on chrome P traps at all lavatories

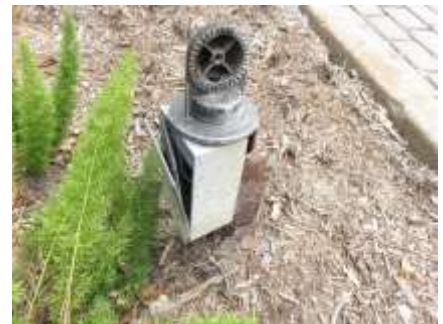
Broken junction box at front exterior sign

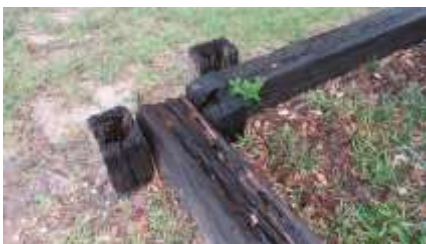
(D) Rotted, damaged and compromised wood railroad ties exist around this building and front signage and drain culvert systems and suggest immediate removal of this material and **perform treatment methodologies** especially within close proximity of building.

Damaged wood railroad ties

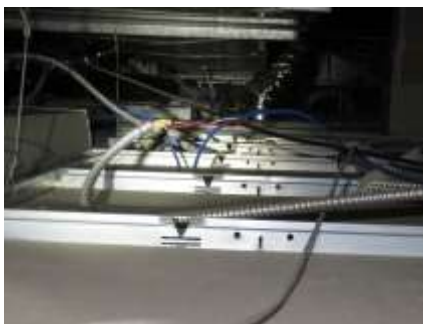
Cut and exposed wires above west ceiling

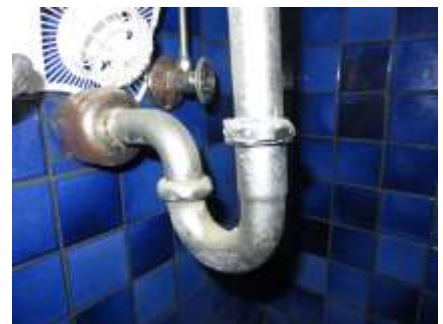
Corrosion on P trap

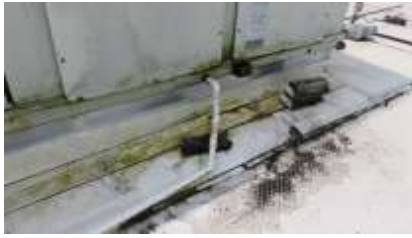
Excess stains and water off HVAC equipment on roof

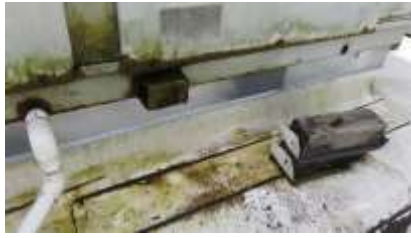
Excess rust and water leakage off Trane unit

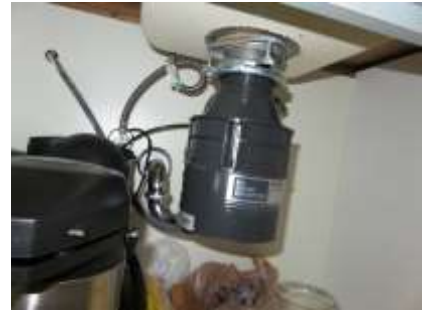
Disposal locked up

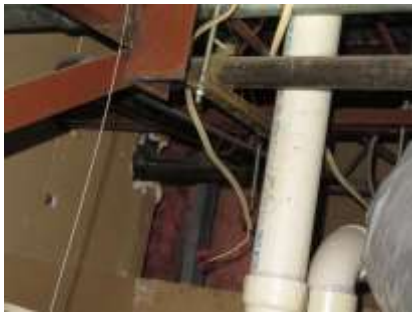
Exposed cable wires

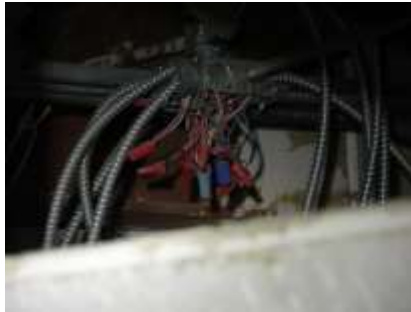
Exposed and unused cable wire above first level men's bathroom

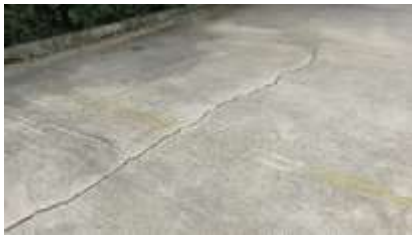
Fractures in south parking lot concrete

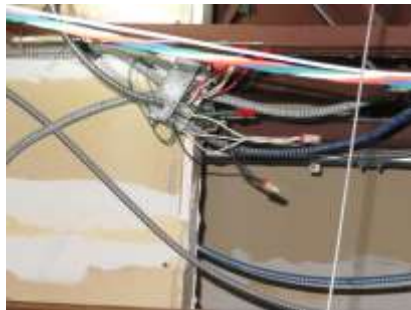
Exposed wires above ceiling tiles

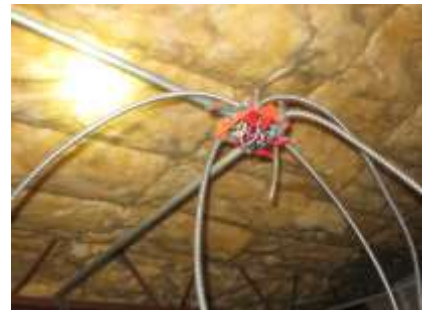
Exposed wires

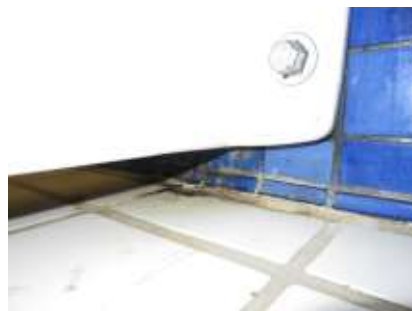
Leaks off toilets

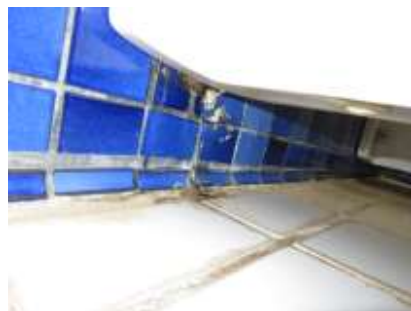
Leakages off toilet

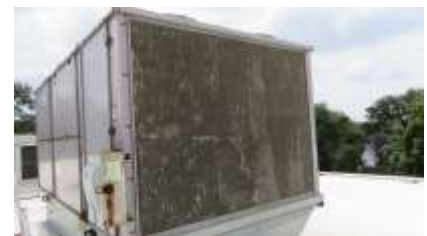
2004 Carrier 3 phase triple compressor, R-22 refrigerant, dual fan motor unit equipped with electric disconnect located on roof for the West 1st and 2nd levels. (D) Damages from suspect hail to condenser coils, rust on electric disconnect, excess oil residue and other stains on housing, loose blower belt on air handler, previous refrigerant repairs and compressor replacements, debris inside of pans in need of thorough cleaning.

Hail damage to Carrier coil

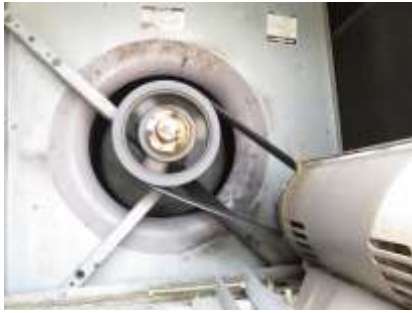
BLOWER AND MOTOR: Belt drive type units. **(D)** Mold/mildew and other residue observed on all blower housing and squirrel cages in addition, loose belts on the Carrier air handler unit along with "vibration" off of these unit when in operation. Therefore, suggest immediate and thorough cleaning of these blowers and adjustments to belts etc.

Mold/mildew on Carrier unit air handler and loose belt

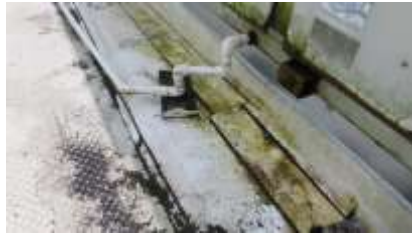
Missing trap off Trane HVAC unit drain pipe

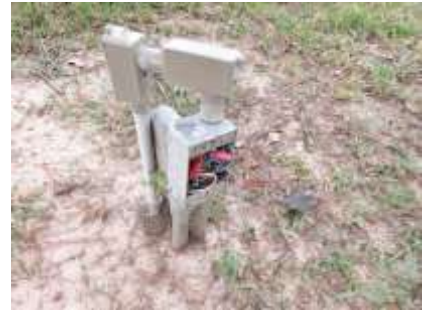
Missing cover on exterior east junction box

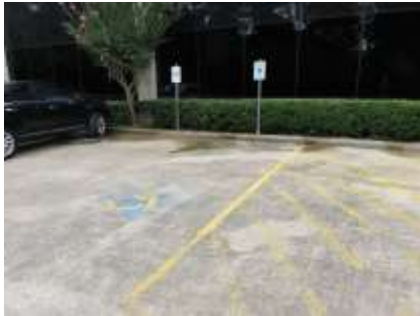
Poor marking for handicap parking

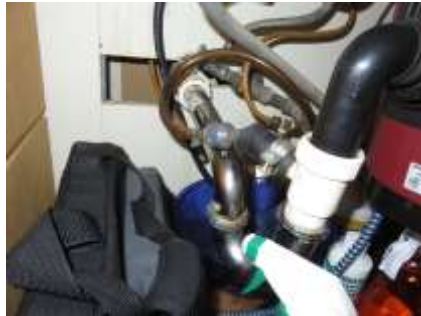
Poor dishwasher drain connection in upper east kitchen

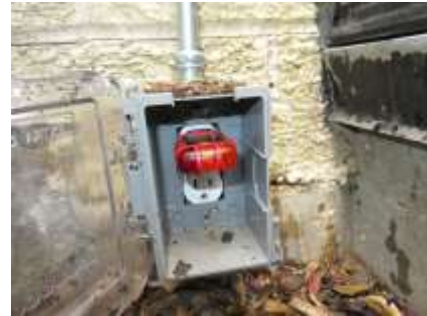
No power on exterior north outlet

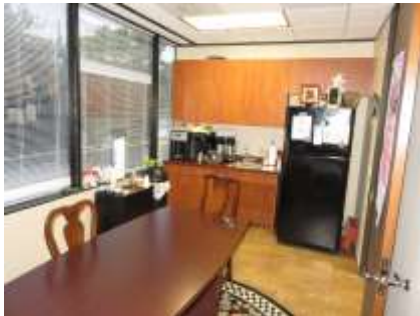
KITCHEN FIXTURE: (D) Rebuild/replace kitchen fixture in second level northeast office.

Replace second level east kitchen fixture

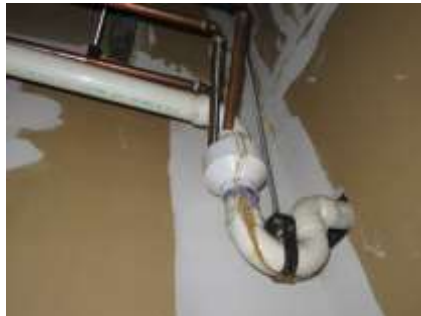
PVC trap with previous leaks in elevator equipment closet

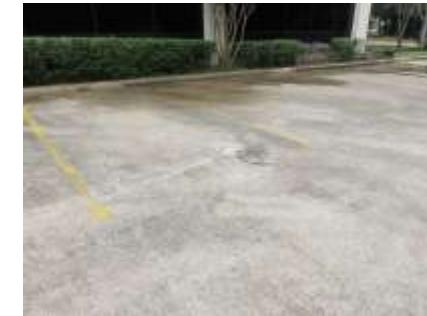
Poor marking for parking

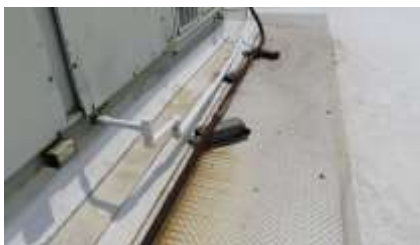
Rusted conduit

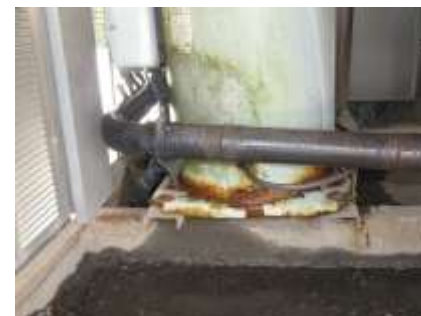
Rusted compressor on Trane unit

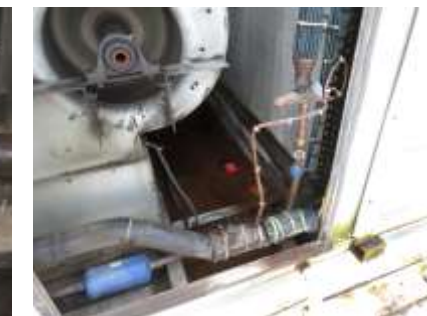
Rust and water in Trane HVAC

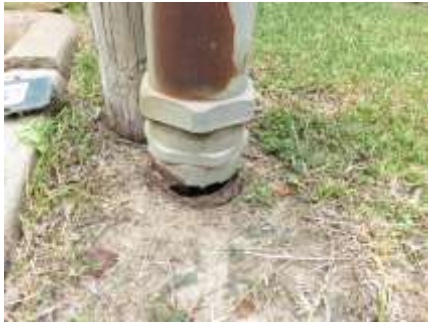
Rusted metal conduit for main feed into building

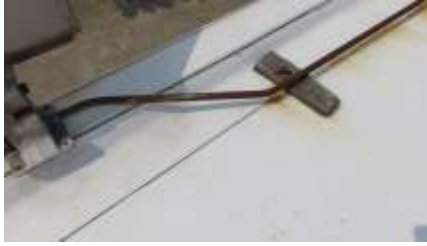
Rusted conduit on roof

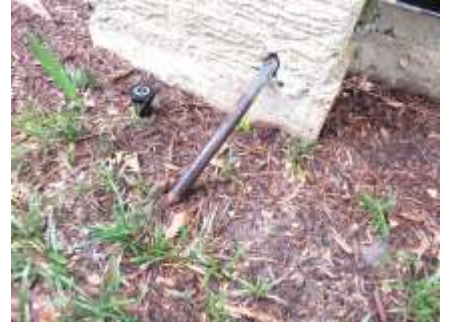
Rusted conduit at east exterior

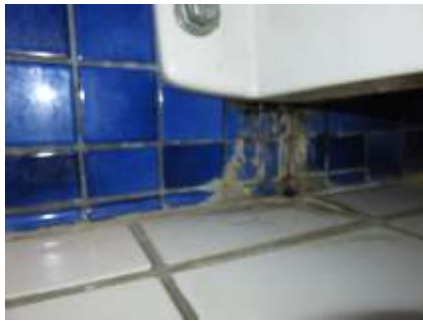
Stains and leakage off toilets

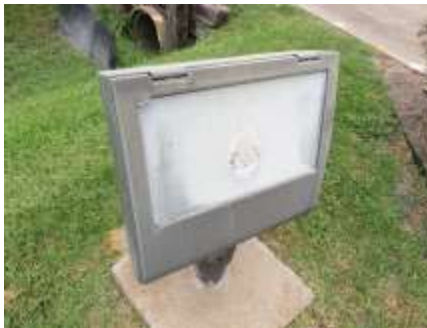
Stained front north security light

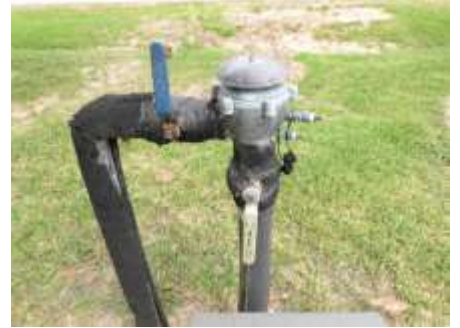
Sprinkler PVB valve on off mode

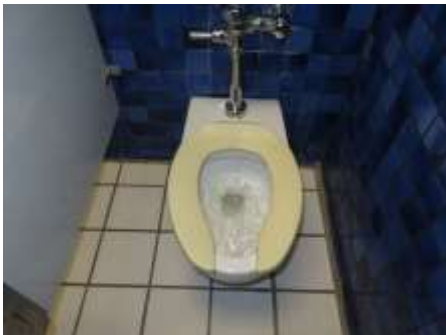
Weak flush on all toilets

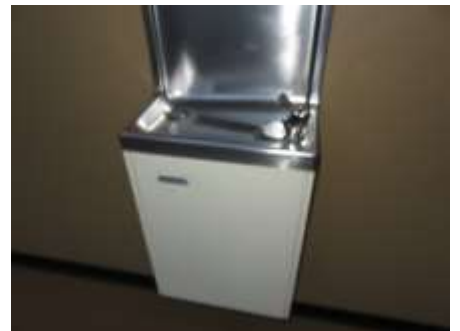
Water cooler not operative
