INFRARED and MOISTURE DIAGNOSTIC REPORT

ABLE INSPECTION CO and INFRARED SERVICES

HOUSE DESCRIPTION

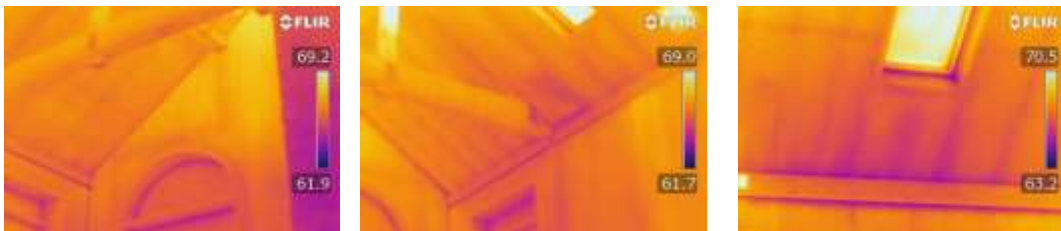
No anomalies on ceiling and walls of family room

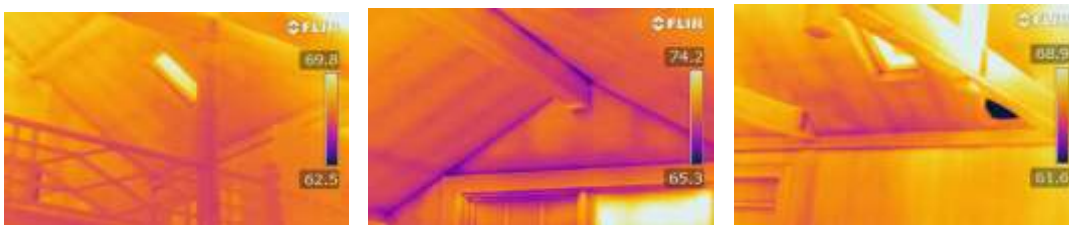
No anomalies on ceiling and walls in family room

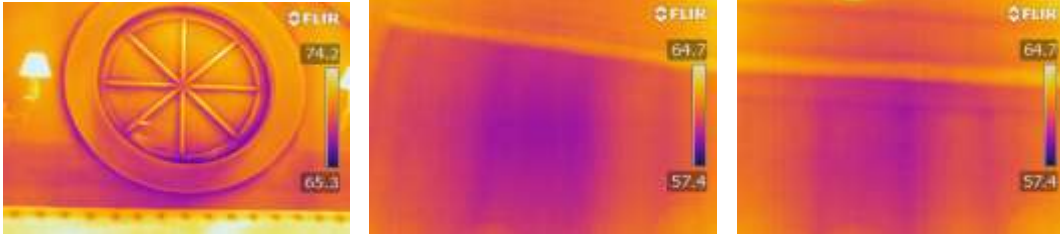
- Stains inside 2nd level south bedroom circular window with removed paneling below in 1st bedroom from apparent previous leaks
- Peeling “blue paint” on 2nd level southeast bedroom door casing for reason unknown

No anomalies at stained oval window and bedroom wall below

- Consult with contractor to examine upper south bedroom oval window and or equivalent for necessary repairs to minimize leakages into bedroom below
- Consult with reputable Irrigation trades to relocate “ALL” sprinkler heads within close proximity of exterior building materials, windows and doors to minimize water intrusion

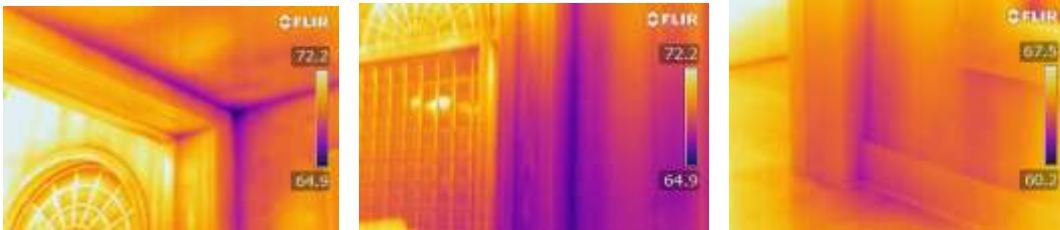
No anomalies at 2nd level south door casing and wall with peeling paint

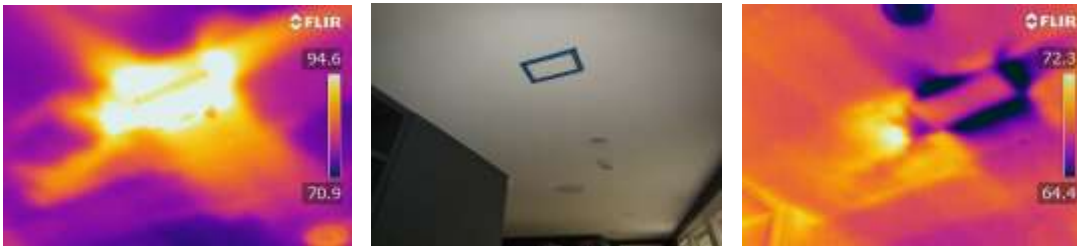
Image of covered air register with drywall in north hallway

- Treat all walls, flooring, ceilings and framing with a quality Microbial solution
- Consult with HVAC trade to correct air supply at family room and north ceiling

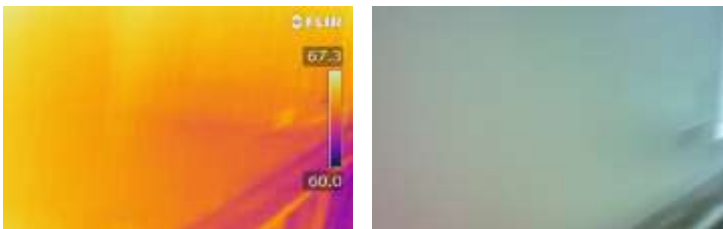
No air supply from one of two south lower family room registers

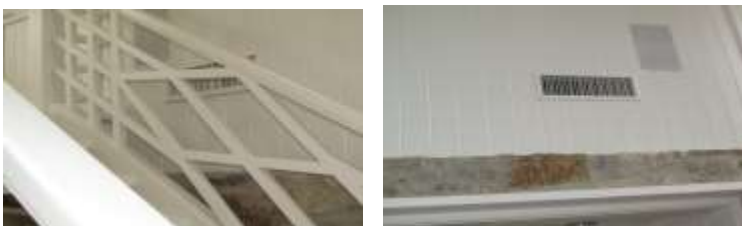
No air supply from one of two south lower family room registers

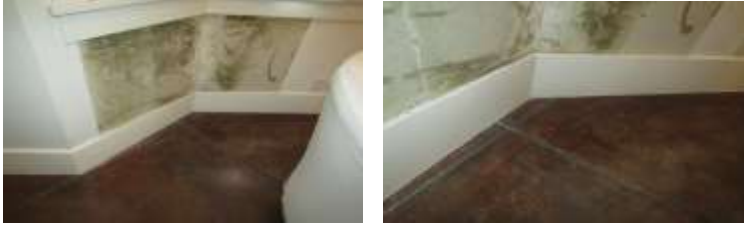
Mold propagation on drywall under 1st southeast bedroom window

- Remove drywall, insulation and treat under 1st level southeast bedroom window affected with water intrusion and existing mold propagation

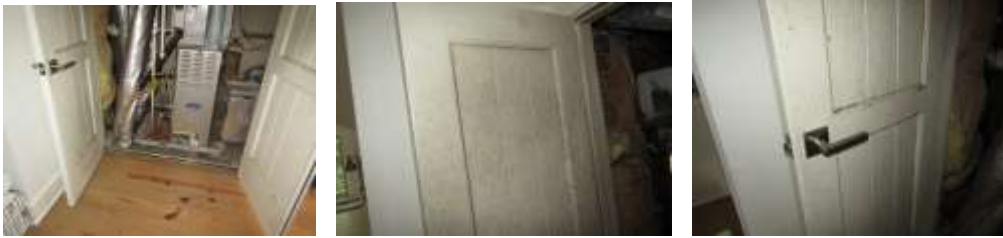
Black organic matter inside of double doors in 2nd south bedroom HVAC

- Consult with reputable HVAC contractors to remove 2nd level south HVAC equipment, ducts, plenums from closet
- Remove all contaminated insulation and ductwork

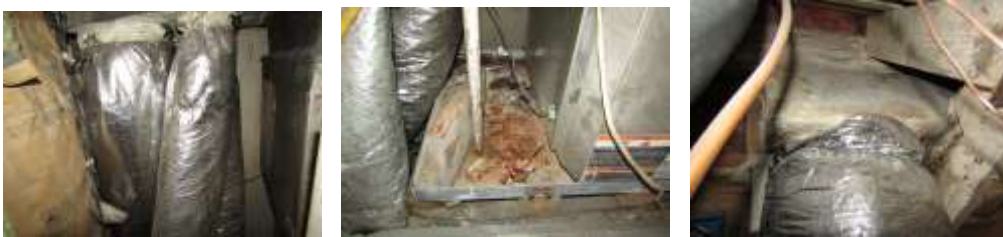
Black organic matter on 2nd level south HVAC ducts and equipment

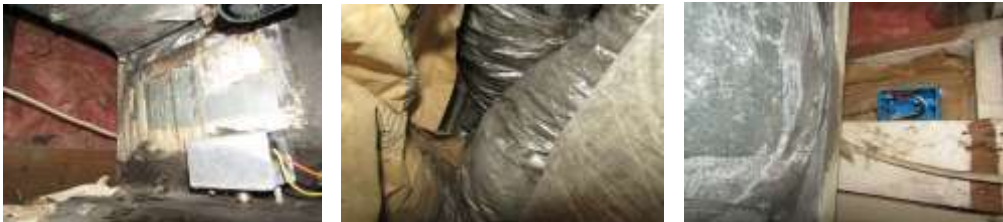
Black organic matter on 2nd level HVAC ducts and plenums...missing cover on jbox

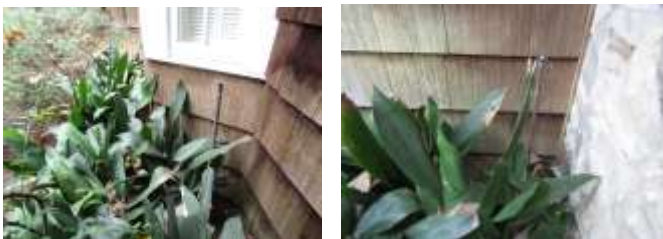
Sprinklers close to exterior building
