**ABLE INSPECTION
COMPANY**
*Inspecting Homes Since
1976*
713 465-0000

PROPERTY INSPECTED:

INSPECTOR: Larry Malloy TREC 332

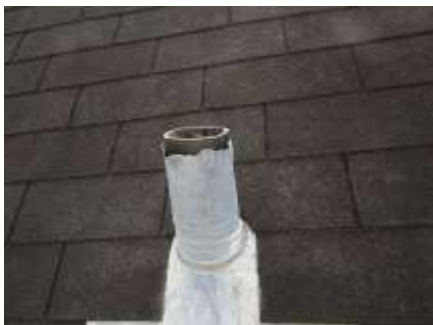
10. Damaged lead roof jacks on gable roof from squirrels and/or equivalent.

Damaged lead roof jack

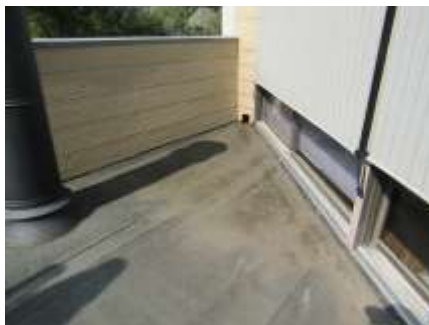
Area of ponding water and excess sealant at door and glazing

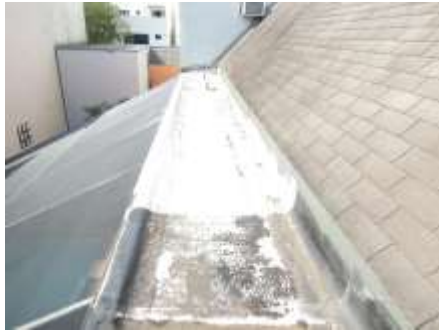
Roof repairs

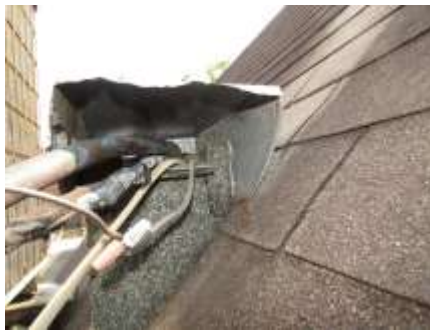
Void at roof jack for HVAC piping

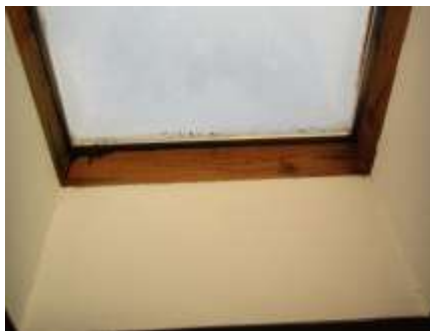
Stains in third level shower skylight

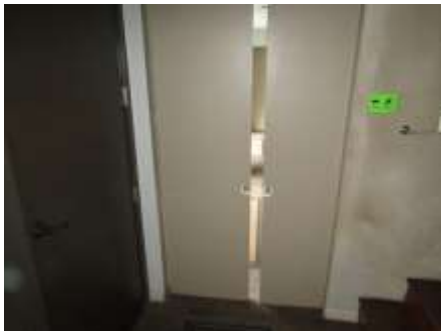
Align sliding doors

22. Align interior sliding doors and install lower guides.
23. Door must be self-closing at garage and breakfast room.

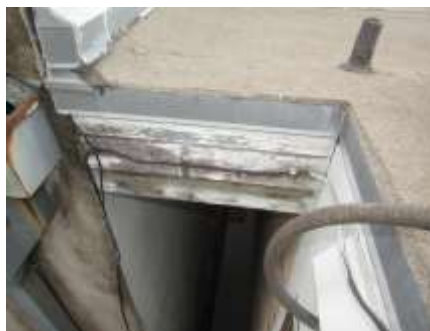
Worn and damaged wood

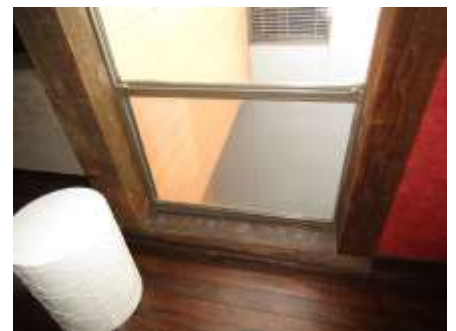
Glass not tempered at top of guest quarters stairs

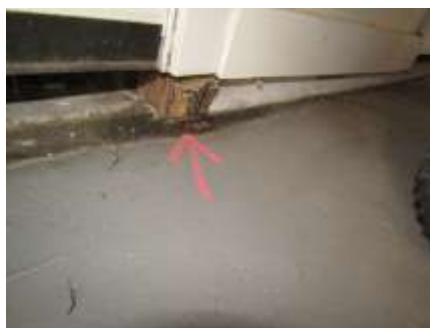
Damaged wood in garage storage door

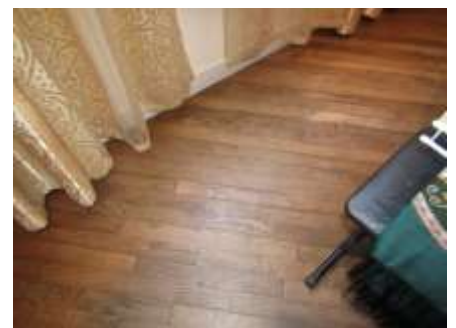
Cupped and popping hardwoods

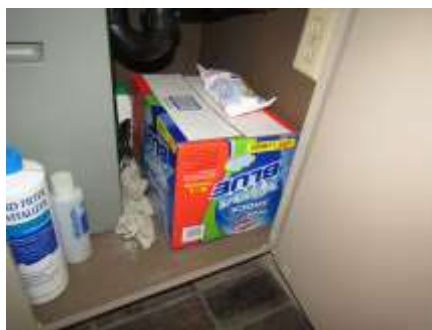
**Remove stored chemicals
under wet bar**

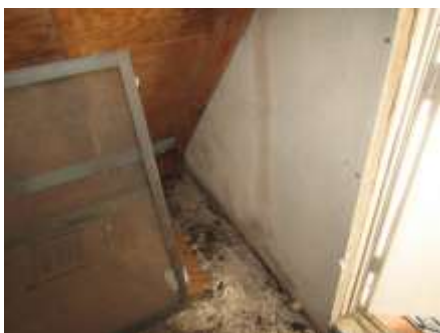
(D) Stained, cupped and separated hardwood floors at random sliding doors and third level office area of sliding door and fixed window glazing. In addition, stains located inside enclosed attic at roof intersection and at rear northeast door off of attic onto roof system from leaks that exist, or did exist at one time.

Stains in attic

It is very important that a prudent buyer retain the services of a reputable and qualified contractor in the immediate future to determine the exact source of leaks, to examine all areas for hidden damages and to expose any possible mold/mildew and provide estimates for the appropriate repairs. Failure to respond to the conditions mentioned above, before the purchase of this property, commonly results in unanticipated, and often costly, repairs.

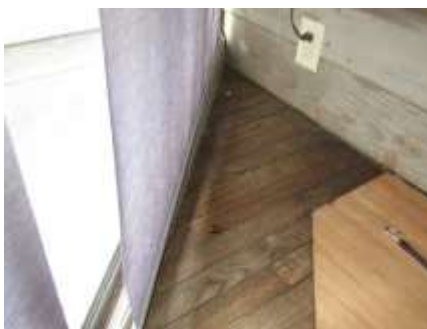
**Cupped and stained third
level hardwoods**

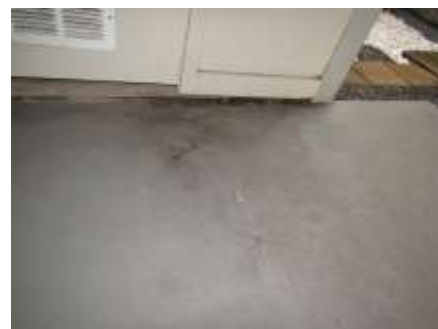
**Water stains on concrete slab
in garage**

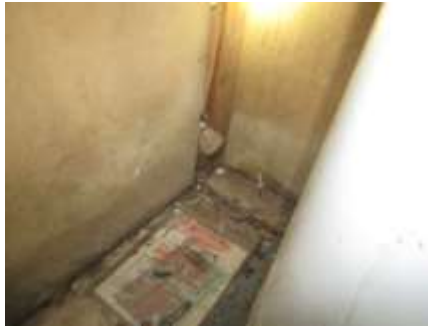
Stains in north water heater closet

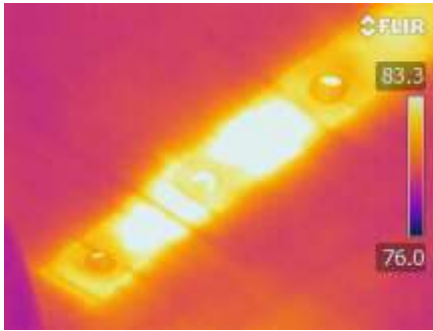
Heat from missing/limited insulation on ceiling on family room

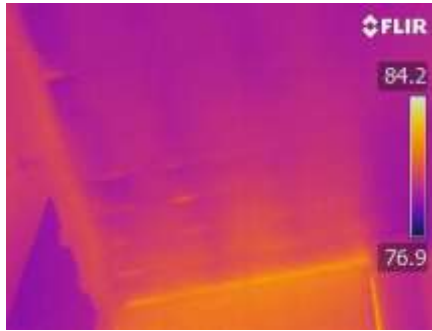
No anomalies on ceiling of family room with stains

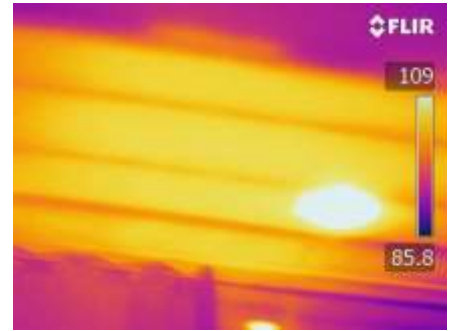
Heat image in upper bath from limited insulation

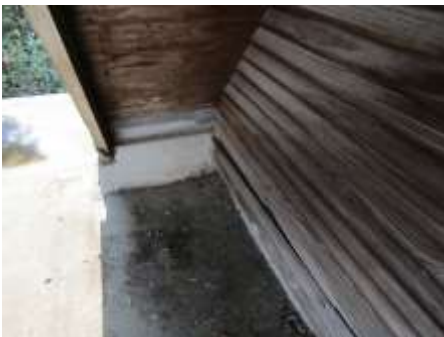
Loose, dry and unpainted wood

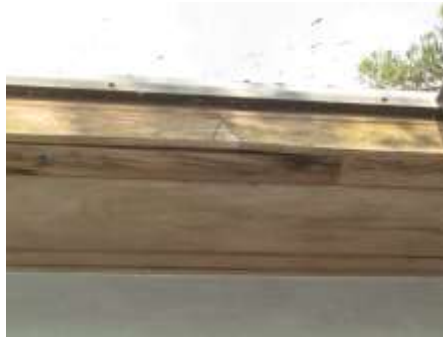
Loose and stained fascia and soffit

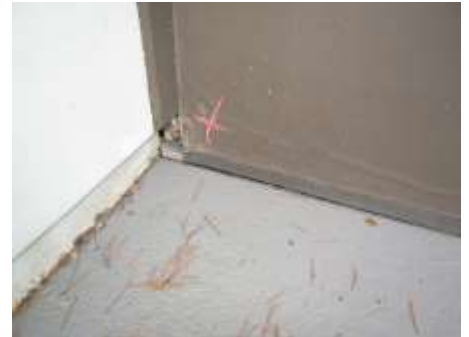
Damaged base of garage door panel

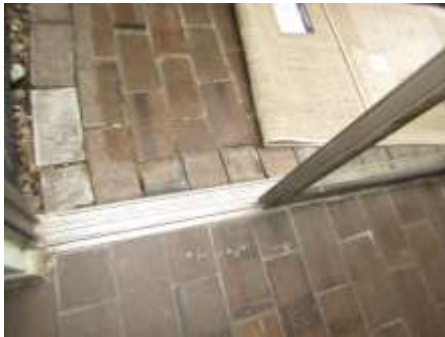
Rough sliding doors

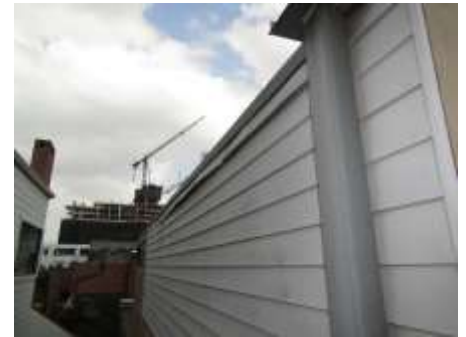
Loose vinyl siding

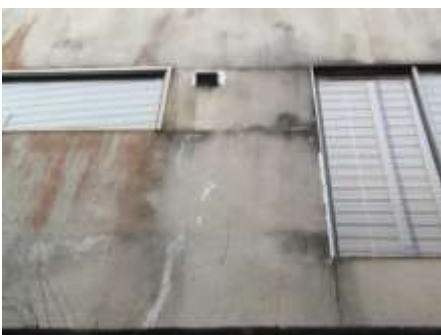
Stained stucco with cracks

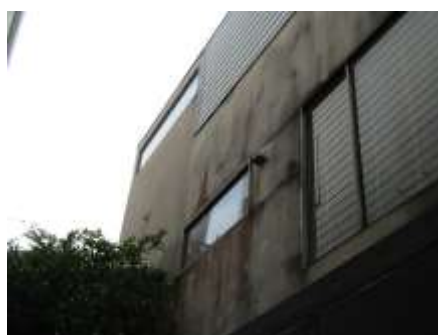
Stained stucco/plaster

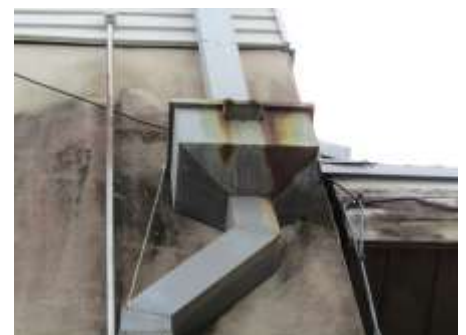
Stained stucco/plaster and rusted roof gutter box

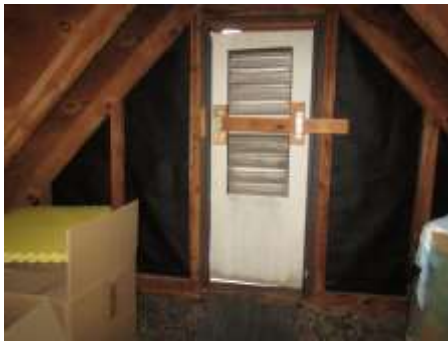
Poor door in attic to roof

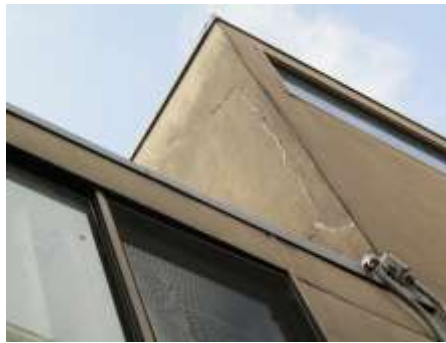
Stucco cracks and repairs

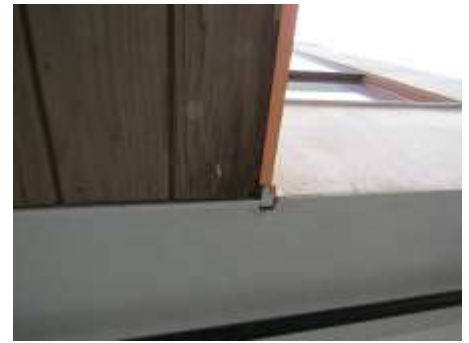
Stained wood ceiling

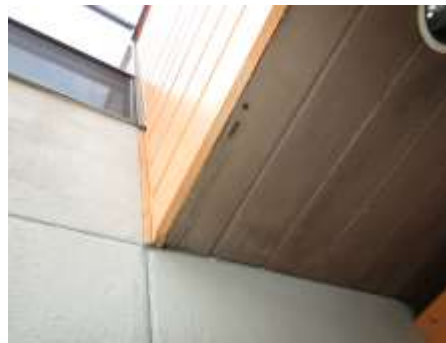
Water stained and damaged ceiling

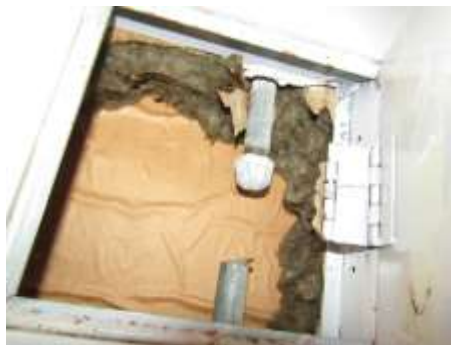
Gas stop valve removed at breakfast room fireplace

(D) These units should be examined by reputable chimney contractors for thorough cleaning, function, operation and integrity.

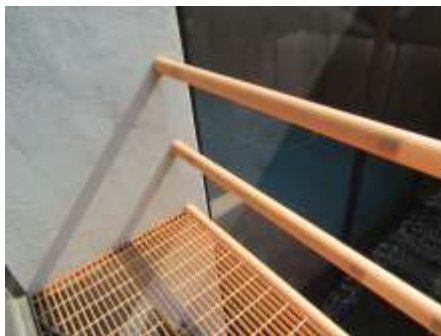
(D) Greater than 4" openings exist at south horizontal steel piping – recognized hazard for small children and no decking installed at third level sliding door opening.

Larger than 4" openings in balcony rails

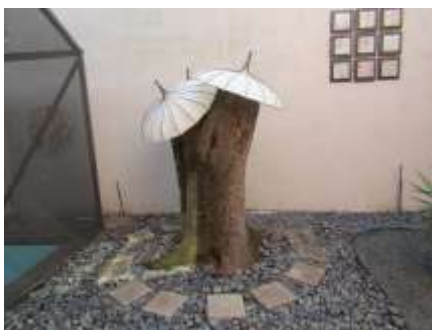
Tree stump in yard

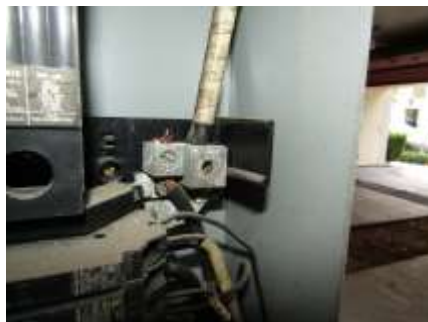
Corrosion on buss and connector

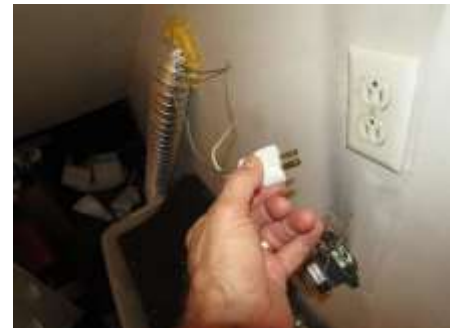
Poor wiring of guest quarters bathroom light and fan

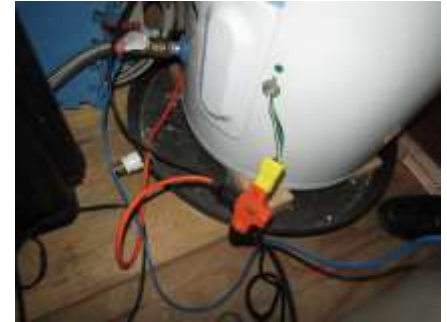
**Improper electric connection
for upper guest quarters
water heater**

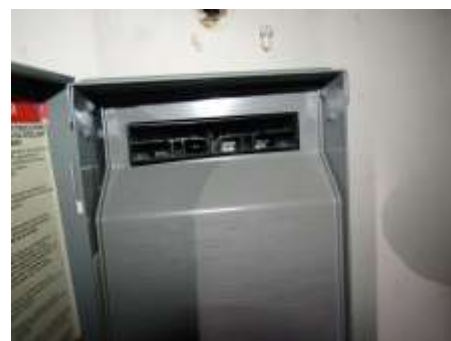
200? Janitrol electric radiant heat with disconnect (guest quarters). **(D)** Burnt disconnect pull plug on wall of closet. Ensure proper sizing of wiring to this electric heater unit. No lighting to illuminate this unit along with readily accessible ladder access. Burnt contacts for guest quarters heater disconnect.

Burnt contacts for guest quarters heater disconnect

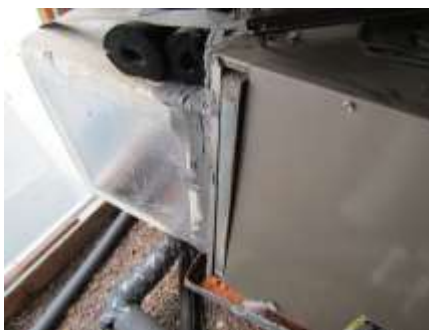
Remove old filter off east HVAC unit

(D) Replace filters at all locations. Clean and seal exposed yellow fiberglass inside first level west unit return chase. One return air installed inside of formal living room closet for the first/second level east unit. Remove in line filter from manufacturer at equipment in attic on east unit.

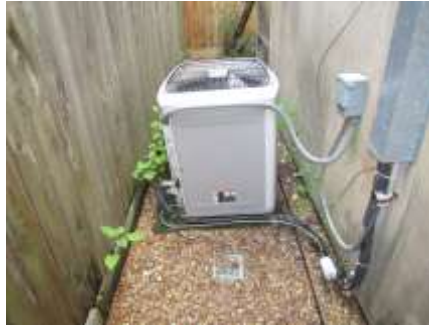
1998 Carrier, R22 refrigerant, 3 ton unit with electric disconnect (first/second level east). **(D)** Clean the condenser coils, insulate any exposed freon line, secure the rain-tite conduit, and seal utilities at the wall projection and level the unit up on the pad. Broken concrete pad. Post-installed and loose low voltage wiring to this unit. Exposed refrigerant line piping with no protection and insulation at upper roof area from attic.

**1998 first/second level _east
A/C**

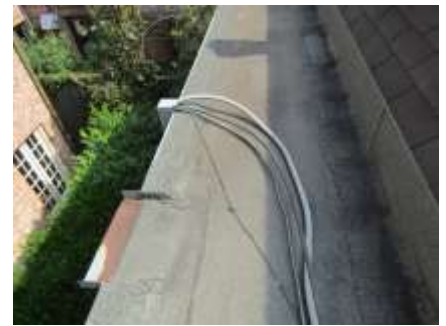
**No protection of refrigerant
line and conduit**

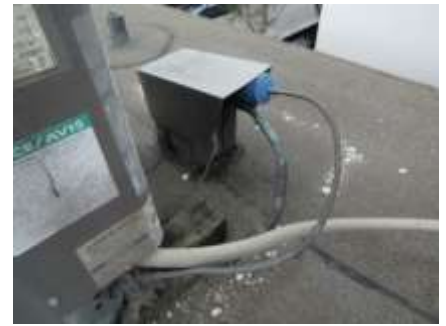
2007 Weather King, R22 refrigerant, 2 ton unit with electric disconnect (guest quarters). **(D)** Improper sized feed wiring from panel box to the rusted electric disconnect. Clean coils on unit. Missing insulation on refrigerant line. Seal voids into roof at roof jack.

**Missing insulation on guest
quarters A/C**

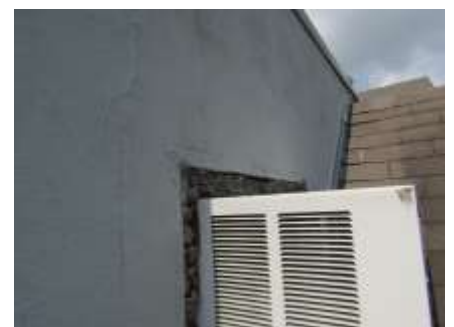
Window unit. LG type located in third level wall. Operative during inspection. **(D)** Improper protective trim/sealant of this unit in stucco wall and no exterior support. Suggest removing and cleaning of this unit.

**Poor sealant around third
level window unit**

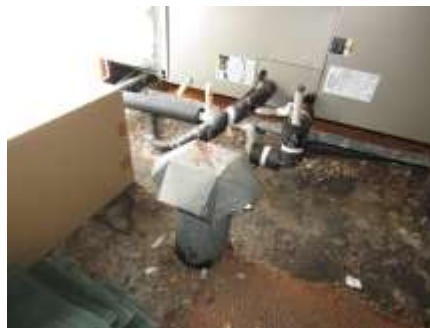
(D) Rust in pan for the first/second level east unit. The drain line is not installed at a high traffic area, commonly above window/door, to allow for viewing in the case of emergency leakages (first/second level east unit – terminates on roof). Black flex piping installed off of guest quarters unit and unknown termination for proper viewing to the exterior.

Rust in emergency pan

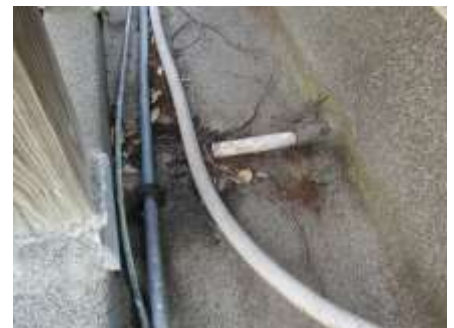
East HVAC emergency drain terminates on roof

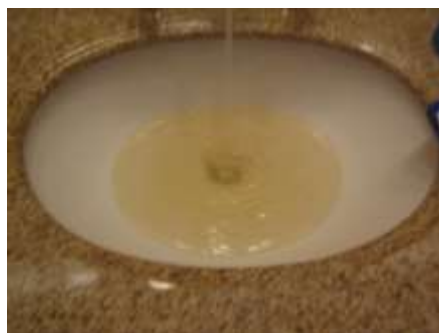
Primarily galvanized steel with CPVC type for the guest quarters. **(D)** Rusted and discolored water noted during operation of random lavatories and tubs commonly the result of galvanized steel water piping that historically will rust, corrode, leak and restrict water supply and suggest obtaining proposals from reputable contractors for further examination of this piping for replacement.

Rust from steel water piping

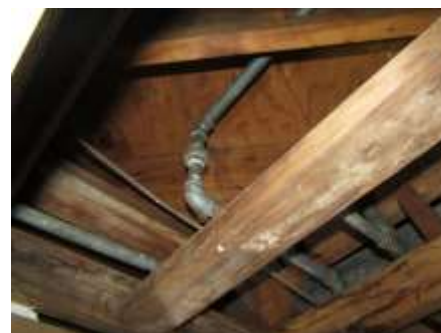
Galvanized steel water piping

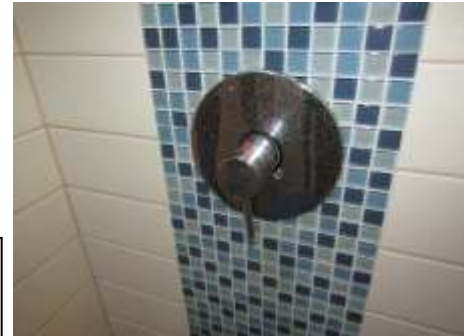
Master anti-scald valve not operative

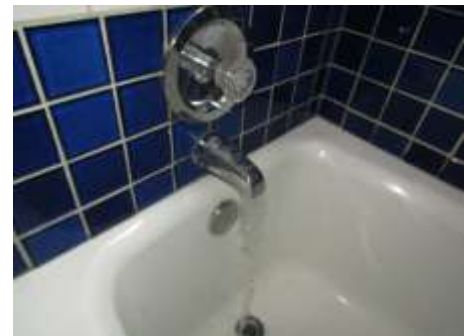
Moen stem difficult to turn off

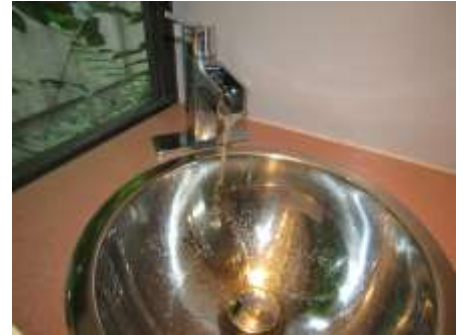
- a) Lavatory (D) Weak hot and cold pressure.

Weak water pressure at powder lavatory

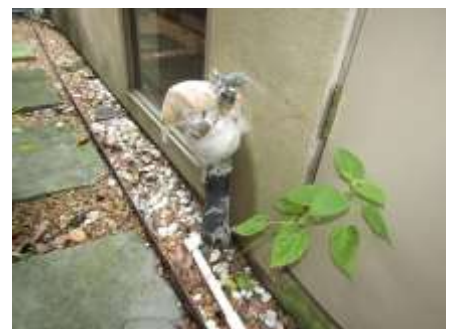
(D) Active leak on piping and post-installed PVC piping at north side hose bibb. No hose bibbs installed on guest quarters and limited number of hose bibbs on exterior of house proper.

Leakage off north side piping

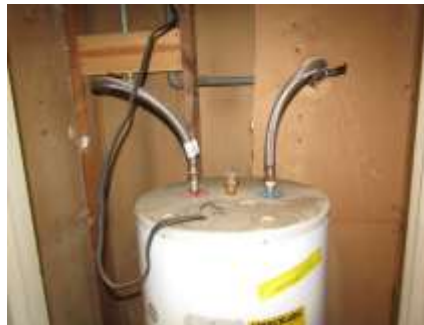
2010 GE 40-gallon electric tank (house proper). (D) Without electric disconnect. Loose electric wiring and missing conduit connector. Slight rust on hot piping connection.

**Loose wire and connection
and missing disconnect**

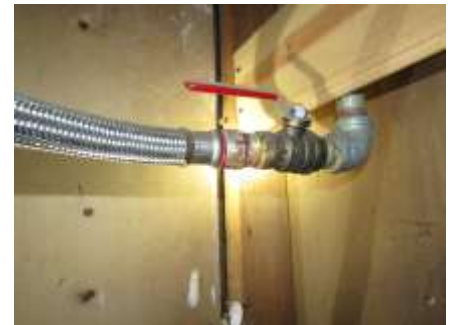
Corrosion on fitting

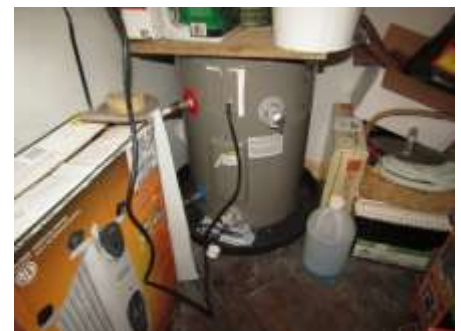
2016 Reliance 19 gallon electric tank (first level guest quarters). (D) Without electric disconnect. Loose cord installed into electric outlet not labeled for this water heater unit. No drain off of emergency pan.

**Secure cord and no drain off
pan and safety valve at guest
quarters**

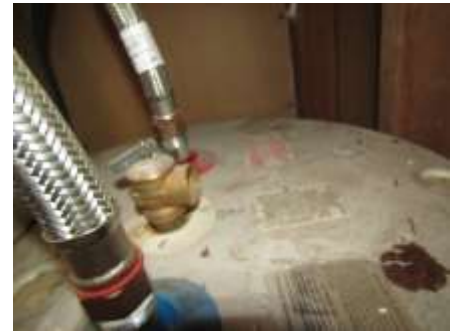
2013 GE 19.9 gallon electric tank (second level guest quarters). **(D)** Without electric disconnect. Improper electrical connection with extension cord and loose cables (recognized hazard). No drain off of emergency pan to the exterior. Consult with plumbing contractor on relocating this water heater unit from closet.

Missing safety valve drain

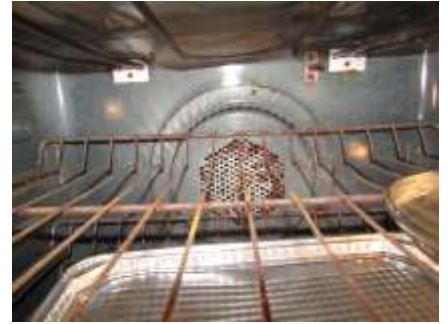
Kitchen Aid electric type with convection mode. 335-345 degrees/350 degrees. **(D)**
Rust on interior metal panels.

Rust inside oven

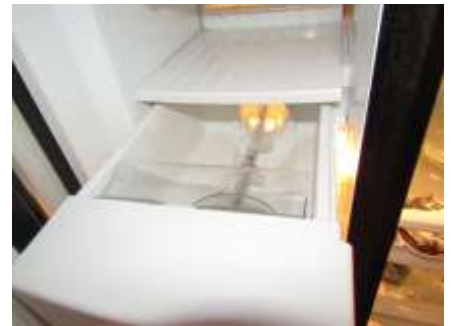
GE type. **(D)** No ice supply in bucket. Clean coils on unit and replace in line filter for the ice maker - this appliance is considered "as is".

No ice in bucket

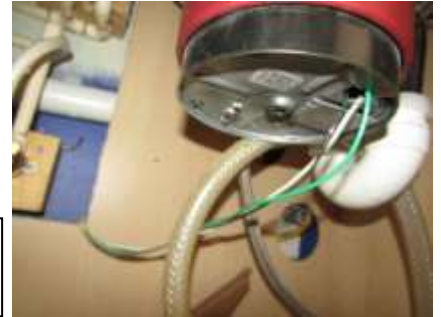
Poor wiring on guest quarters disposal

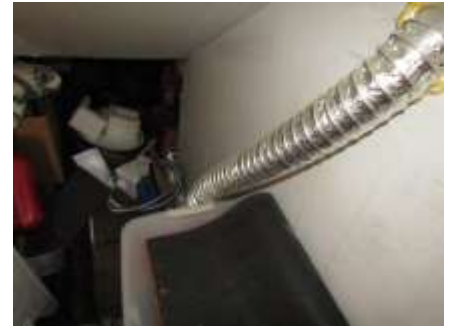
Poor vent termination off
guest quarters bathroom

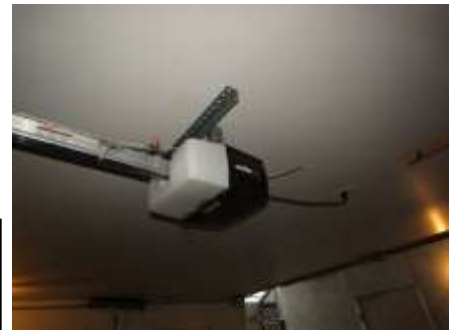
Old generation garage door
operator

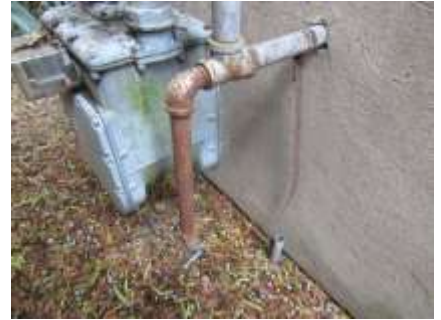
(D) Old style, worn, rusted and difficult to operate brass gas stop valves, which are a recognized safety hazard, are located off of gas meter for previous pool heater unit and we suggest removing and replacing stop valves with current and easier to operate valves. Gas valve removed at breakfast room fireplace.

Rusted piping and old gas stop for previous pool heater

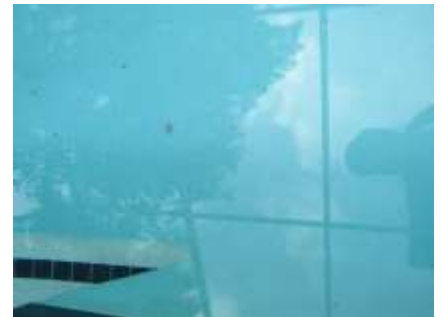
Crack in pool plaster

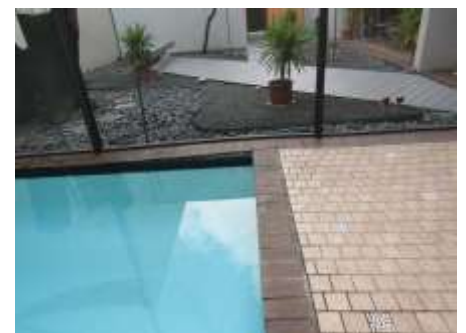
Heave and deflection of pool beam and tile

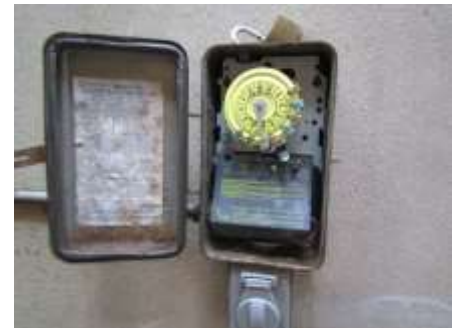
PUMP & STRAINER:	(D) Air in pot during operation from suspect leak on pool system and/or piping.
MOTOR/TIMER:	3/4 H.P. motor with time clock controls. (D) This inspector is of the opinion this motor pump is undersized for this size of pool. Rusted time clock.

Rusted time clock

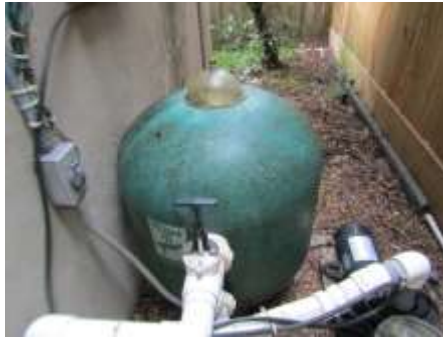
Old generation sand filter

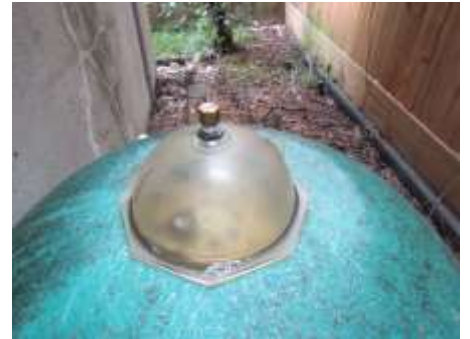
Missing gauge on dome

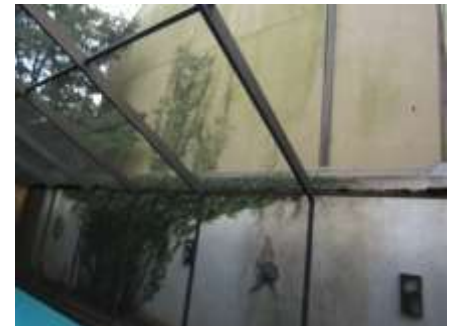
(D) Damaged door for enclosed screen. Tree debris on screening and rust at base of metal framing.

Tree debris
