**ABLE INSPECTION  
COMPANY**  
*Inspecting New  
Townhomes Since 1976*  
**713 465-0000**

CLIENT: Joe Sample

DATE – November , 2018

**NEW TOWNHOUSE DESCRIPTION w/ATTACHED TWO CAR GARAGE**

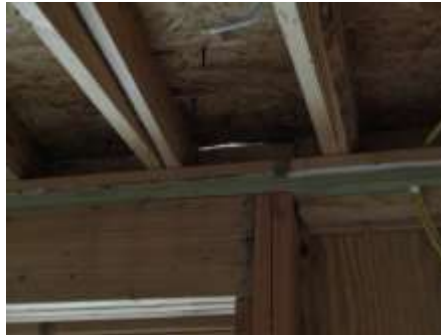
1. Daylight around edges of fourth level roof.
2. Random roof leakages in 4<sup>th</sup> level areas (marked with paint)

**Daylight around edges of fourth level roof**

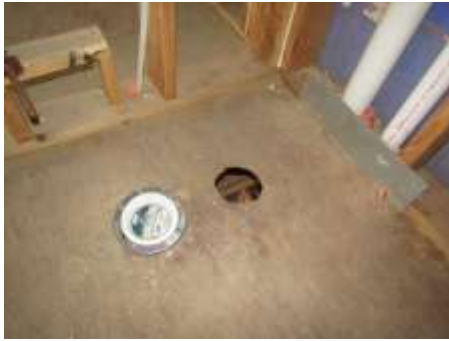
**Hole in sub floor in second level toilet closet**

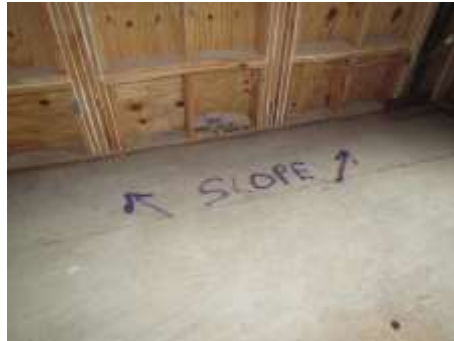
**Floor deflections in second level kitchen**

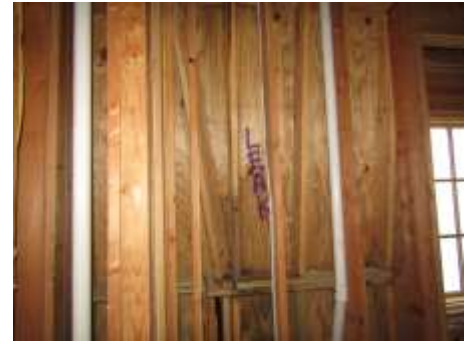
**Active roof leakage in fourth level**

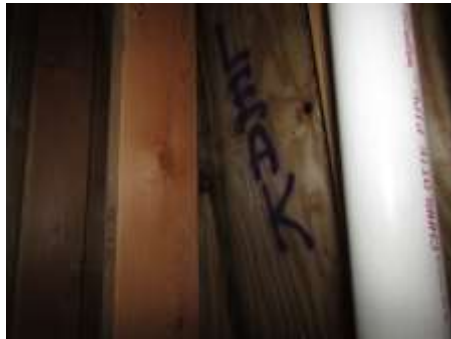
**Leak in fourth level from roof**

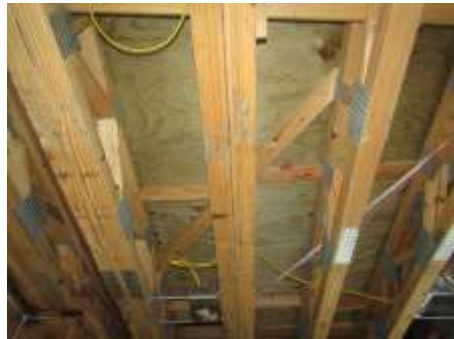
**Infrared revealing moisture from water on fourth level balcony deck**

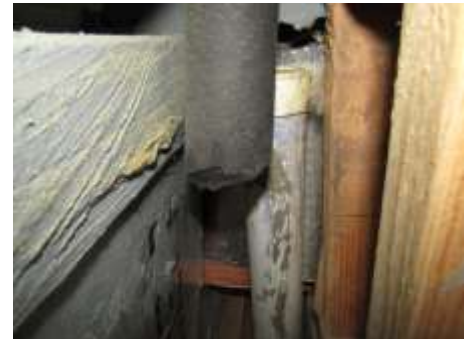
**HVAC primary drain not installed**

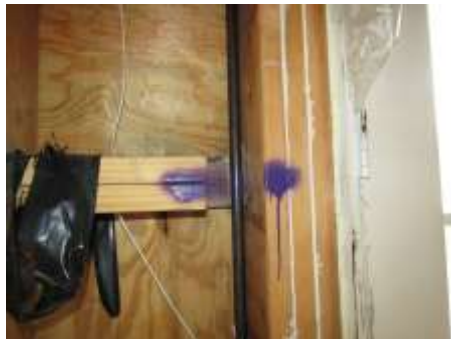
**Missing strap on gas pipe**

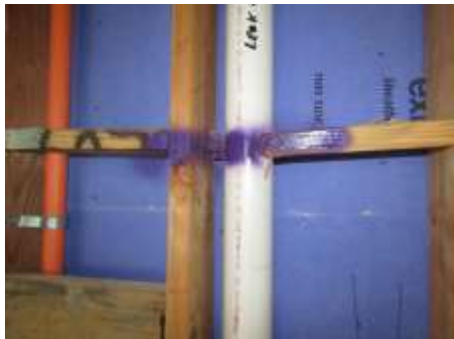
**Missing strap on second level PVC drain pipe**

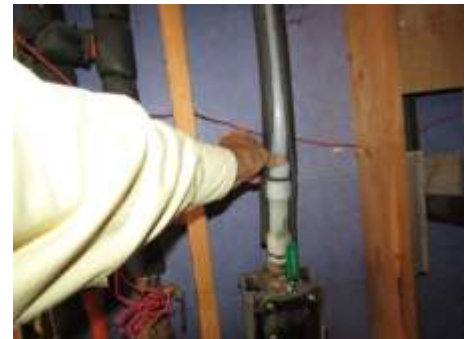
**Loose Pex water line piping in garage**

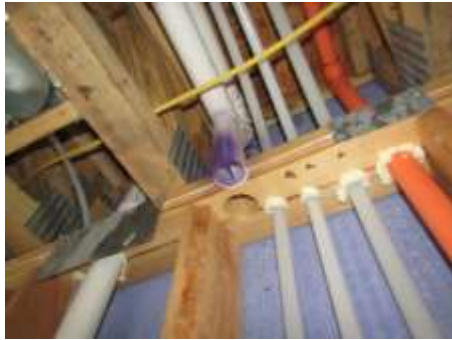
**PVC pipe securing drain above**

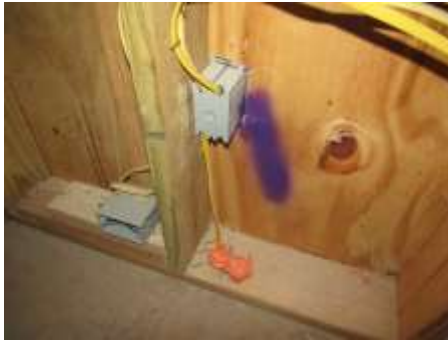
**No fire stop sealant at outlet to balcony**

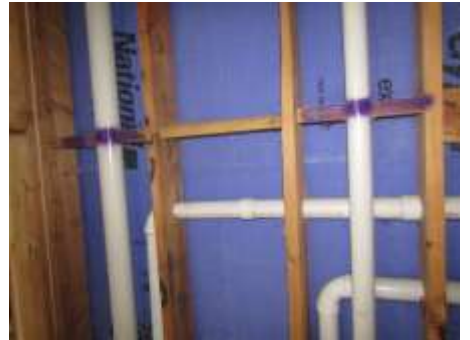
**Missing strap on PVC drain pipes**

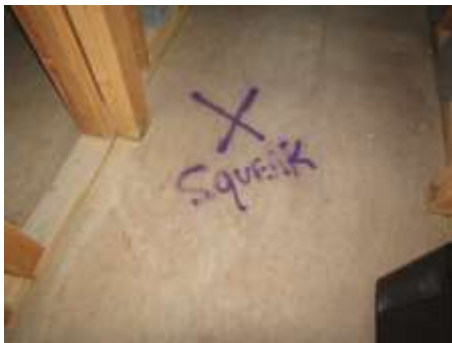
**Secure loose and squeaking third level sub floor**

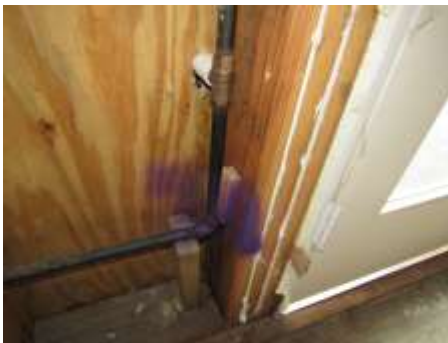
**Secure gas pipe to balcony**

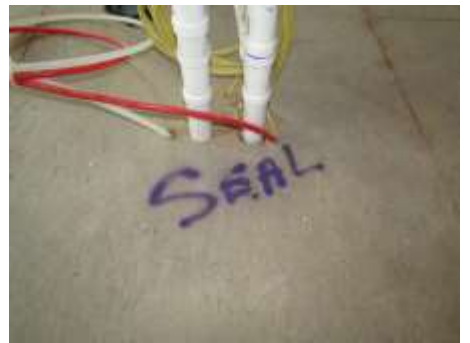
**Seal voids at kitchen water, electric and drain pipes**

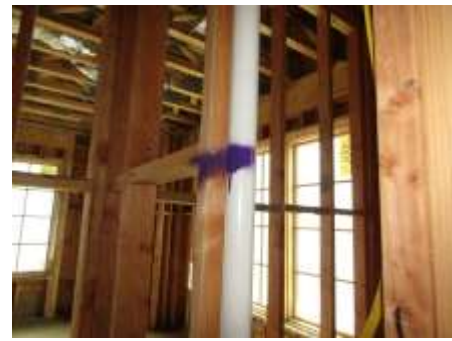
**Strap loose PVC drain piping**

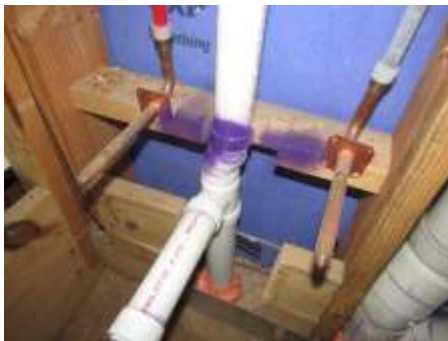
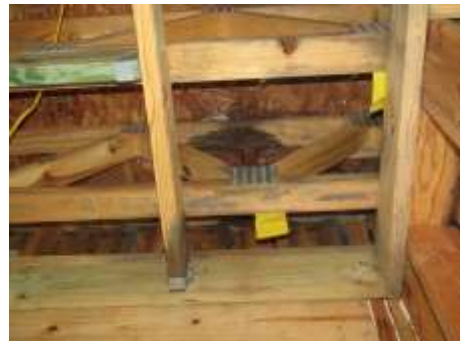
**Stained second level sub floor from previous leaks**

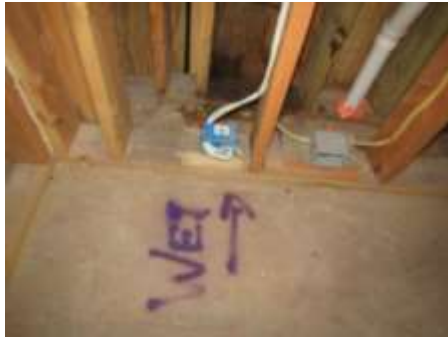
**Wet area in fourth level from roof leakage**

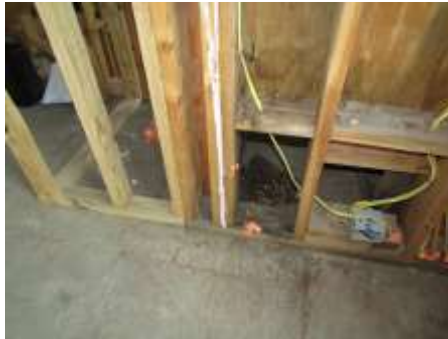
**Water in second level south floor**

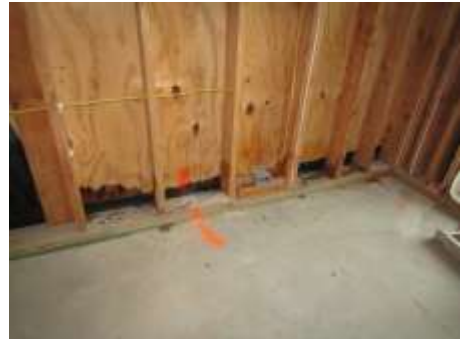
**Water at base of common north wall from Unit #35**

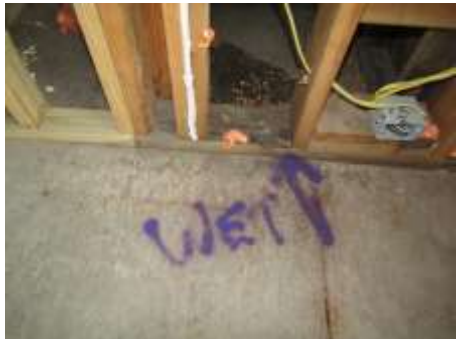
**Wet sub floor in second level**

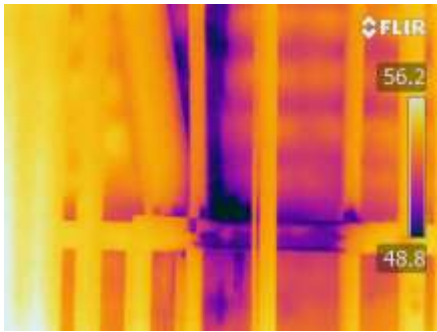
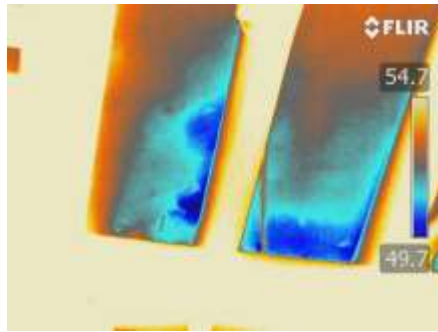
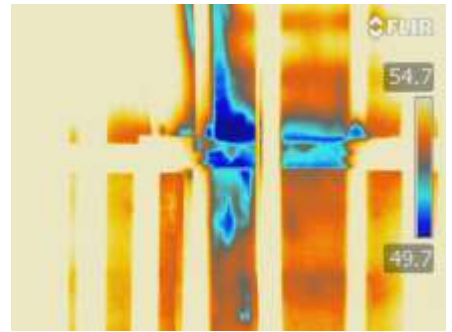
**Active water leakage in 4th level roof deck and wall**

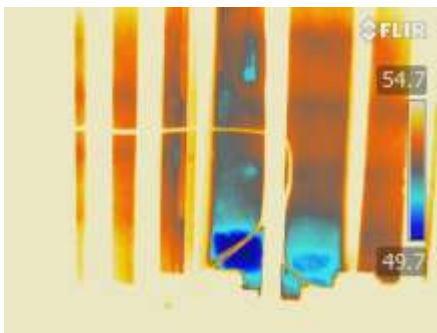
**Active water leakage in 4th level roof**

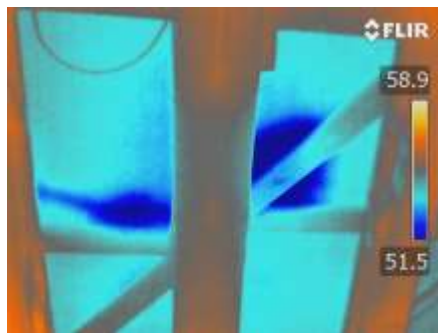
**Active water on ceiling of 3rd level east under balcony**

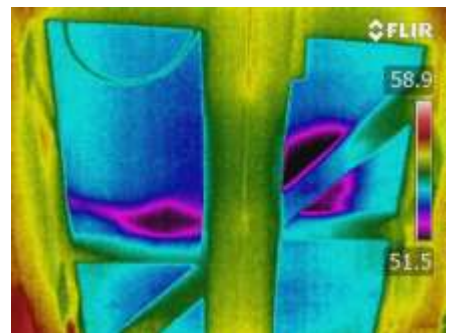
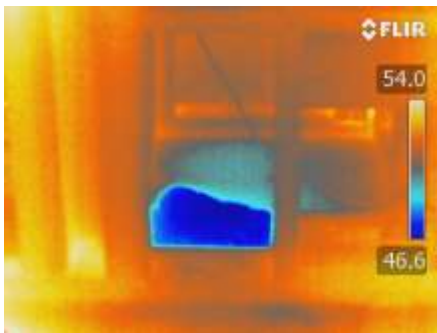
**Water image in 2nd level south chase**

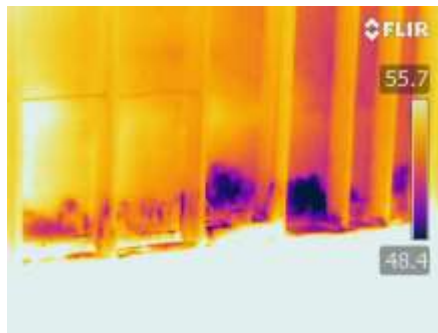
**Water images inside 1st level northeast wall**

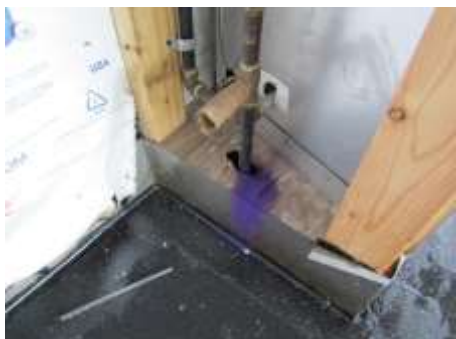
Seal gas piping at balcony fireplace

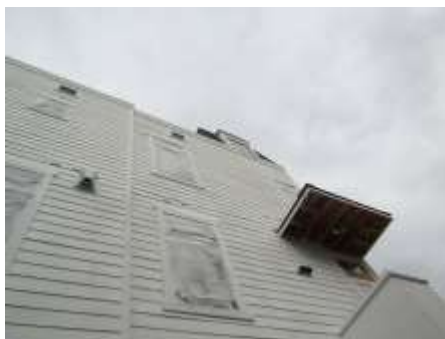
Seal all exterior penetrations

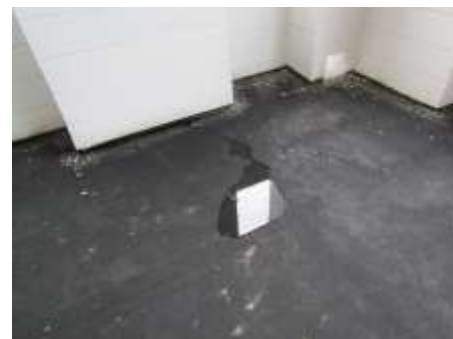
Ponding water on fourth level balcony

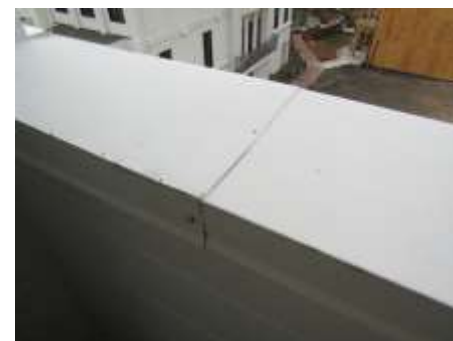
Seal metal cap joints
