HOBBY LOBBY BUILDING

PICTURES AND INFRARED IMAGES ON HOBBY LOBBY BUILDING

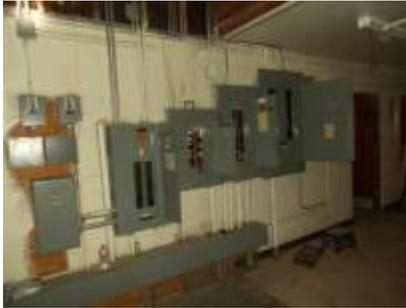
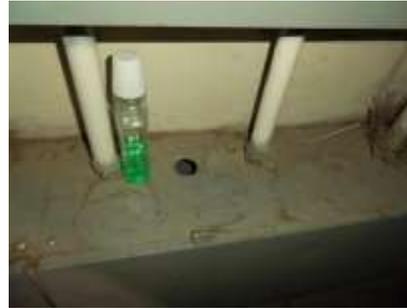
- Four 3-phase, Square D panel boards are located at the back hallway service area (three 225 amp and one 100 amp). Two panels re labeled (CL and LP-K) and two are not labeled. One unlabeled panel has missing breaker legend. Several panel cover knock-out plates are missing at the LP-K panel. A few panel cover screws are also missing. The raceway/wiring tray below the panel boards has a missing knock-out.

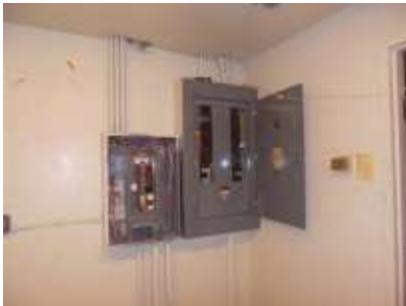
- Two 3-phase, Square D panel boards are located at the back office area on the east side behind the main retail area. One of these panel covers was removed and laying on the floor at the time of inspection.

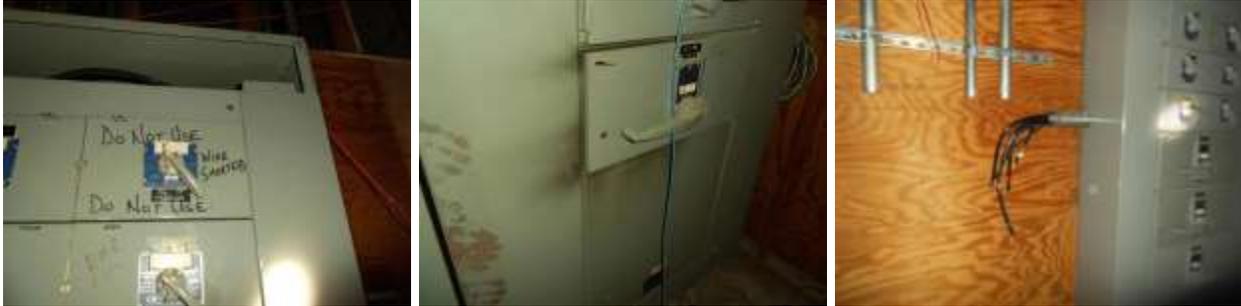
- The main electrical service room where the power transformer is located has several Square D power distribution panels with numerous Saflex, QMB type fusible disconnect switches. Most of these switches were turned off at the time of this inspection. Signs of over-heating or shorting were observed at one or more breakers and more than a few are labeled “disconnected” “shorted” “do not use” “empty” “cut wire” “bad switch” or something similar, therefore, it was considered to be unsafe or unwise to operate any of these switches. Recommend further evaluation by a licensed electrician familiar with commercial wiring.

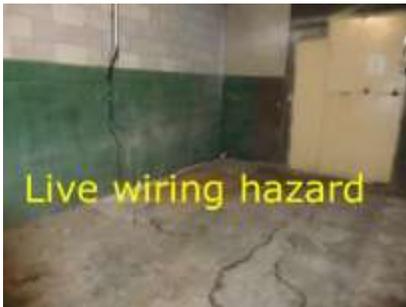
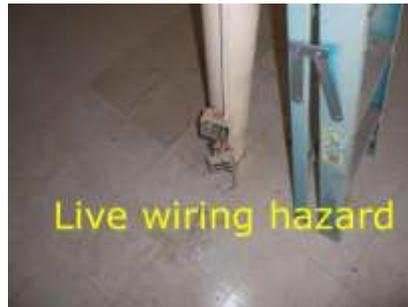
- Abandoned wiring was observed in several places throughout the building where equipment has been removed, such as the trash compactor, restaurant equipment, space heaters, etc. and the wiring where the trash compactor appears to have been located is still “live” or “hot” – a major electrical hazard. Live wiring was also discovered at one broken outlet box on a support column near the front entry check-out area. Check abandoned wiring behind the water heater. Exposed wiring without conduit was observed at the water softener outlet. The water heater jacket in the women’s restroom appeared to be energized when checked with a voltage “sniffer” which appears to indicate a “short” and/or could be an electrical hazard. Recommend further inspection/evaluation by a licensed electrician to ensure that all abandoned, unused or potentially unsafe wiring is de-energized.

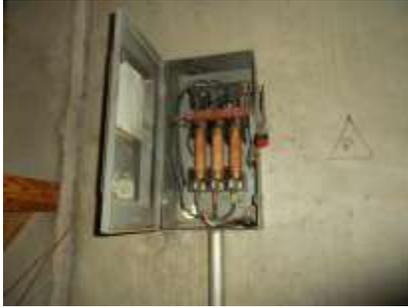
- Fused disconnect in main electrical room with unknown functions (wire to exterior cut-off and switched off).

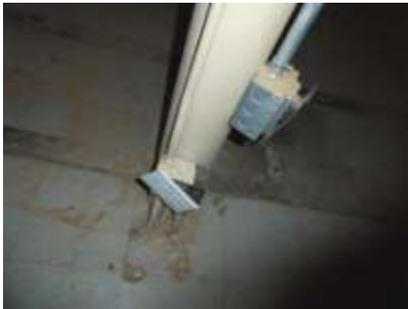
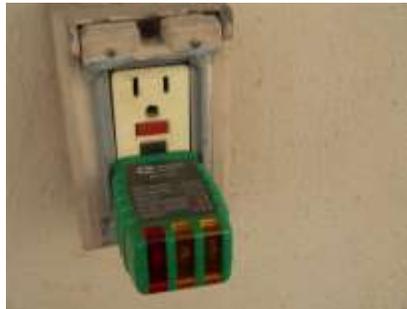
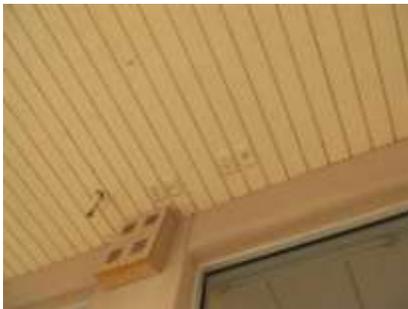
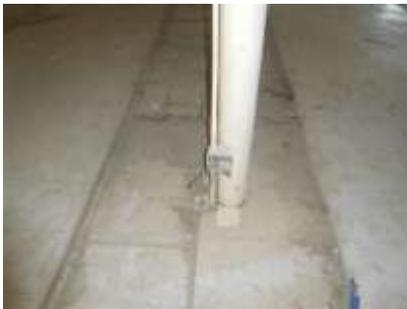
- Not all outlets were working at the time of inspection or circuits may have been turned off.
- Re-attach any outlet cover plates that are loose and replace any missing outlet cover plates.
- Exterior G.F.C.I. outlets at the front of the building have broken cover plates.
- Exterior outlets at the soffit above the front entry/exit doors should have weatherproof covers.

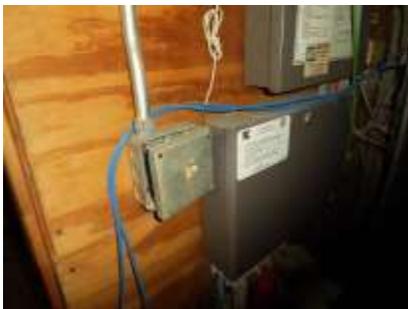
- Not all switches could be tested where power is off or disconnected.
- Re-attach any switch plate covers that are loose and replace switch plate covers where missing or damaged.

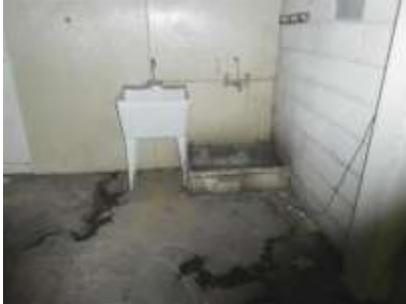
- The G.F.C.I. outlet at the kitchen sink/break room area failed to test.
- Exterior G.F.C.I. outlets at the front of the building where not working or the circuit may be turned off.
- The outlet at the water softener was turned off or not working at the time of inspection.
- Outlet at mop sink/utility sink did not appear to be G.F.C.I. protected.

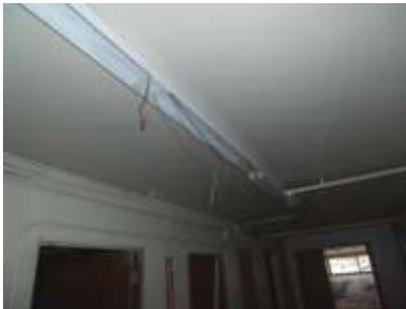
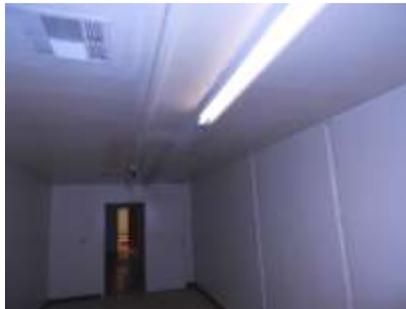
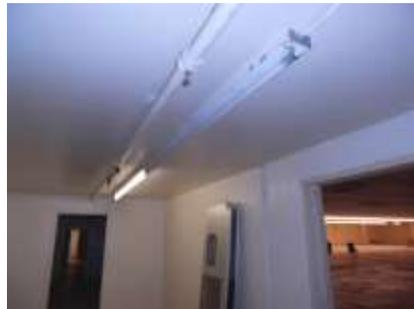
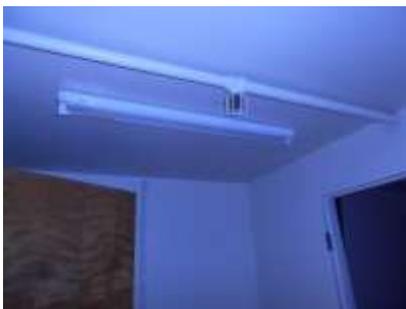
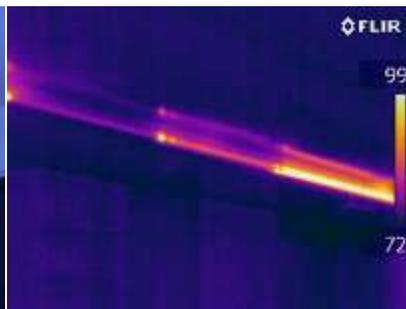
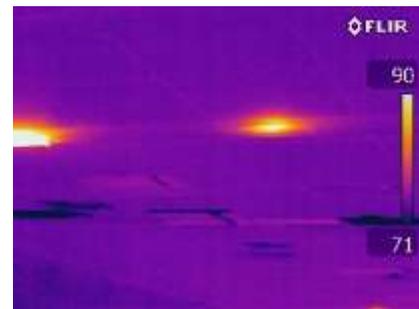
- Very few lights were turned-on or working at the time of inspection, mostly on the east side of the building main retail area. Only few lights were working the back part of the build.
- Many light fixtures have bad or missing bulbs, missing ballasts, etc. FLIR™ infrared camera appeared to show evidence of some fluorescent lighting ballasts that are defective or over-heating. Repair, replace or disconnect defective/missing light fixtures as needed or desired.

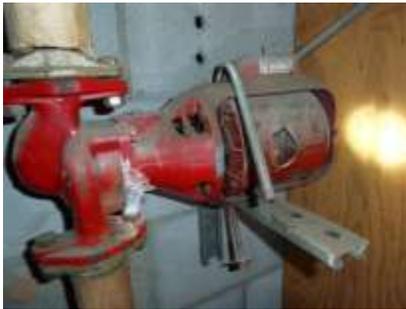
Circulating Pump: The pump is corroded and was not running/working at the time of inspection

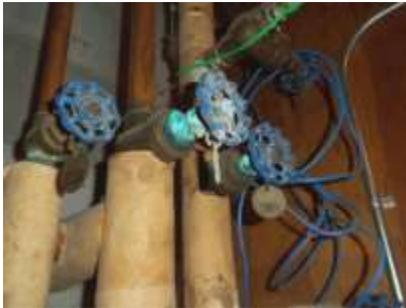
Control & Shut-off Valves: Two or more gate valves are corroded at the water heater/water softener closet area.

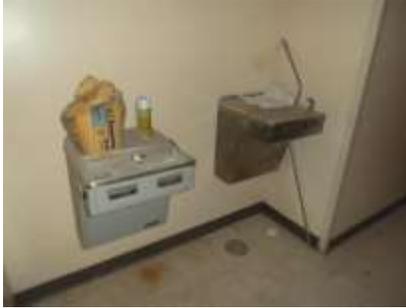
- The drinking fountains were not working at the time of inspection. Rust on the floor tile below the left drinking fountain could indicate leakage.

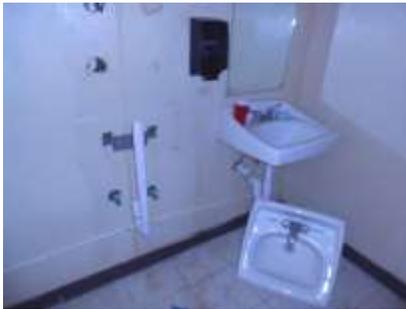
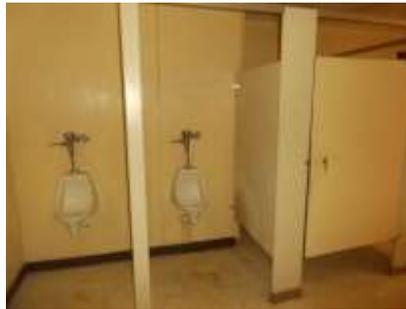
One sink pulled off the wall/on floor and the other sink is loose/faucet leaking.
Staining on wall below right urinal could indicate leakage.
The tank lid is missing.

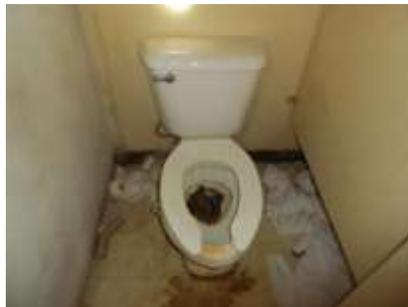
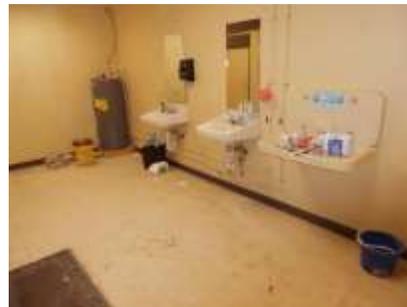
Appear functional.
The showers appear to be poorly constructed. May not have a shower pan or adequate water-proofing. Tiles are separated at corners. One shower head removed or missing. Water piping to showers is also poorly secured/installed.
May be clogged with paper/debris.

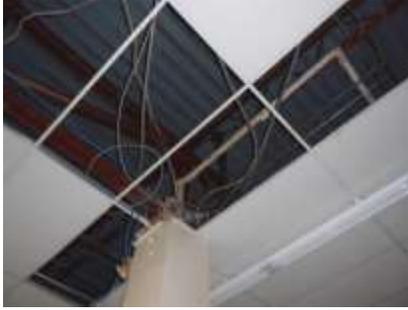
- There is some drain and/or water piping inside the ceiling and one of the columns toward the front of the store on the west side that shows evidence of leakage.

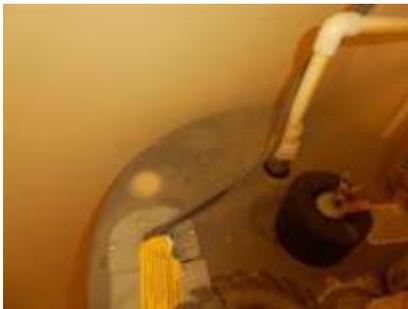
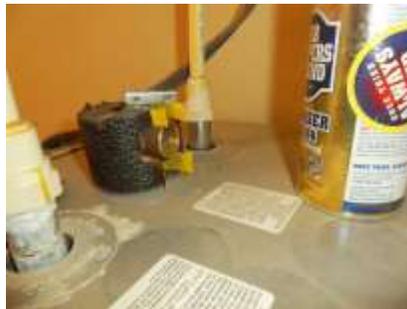
- Two 30 gallon electric water heaters. The water heater in the closet where the circulating pump is located is approximately 15 years old and the bathroom water heater is approximately 1 year old. The water heater in the women's restroom is energized but did not appear to be working. There is no disconnect switch, no strain relief and the water heater jacket was apparently energized (**shock hazard**).

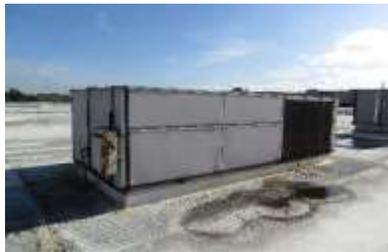
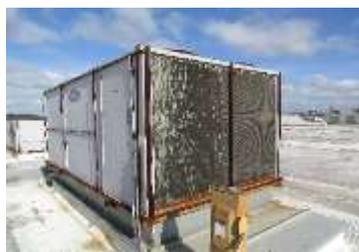
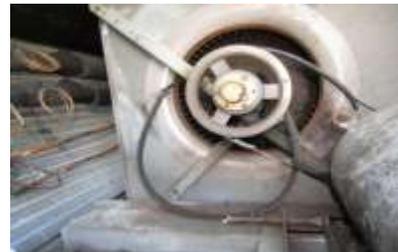
- ?? age Lennox for rear southeast with rusted disconnects
- 1997 Carrier for rear southwest
- Two 2006 Carrier for front north – broken belt off motor
- ?? age Carrier for middle west – cover off unit
- Blank spaces from previous units at east side roof

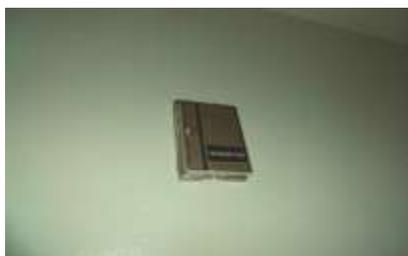
- Exhaust fan control in conference room/office did not appear to be functional.

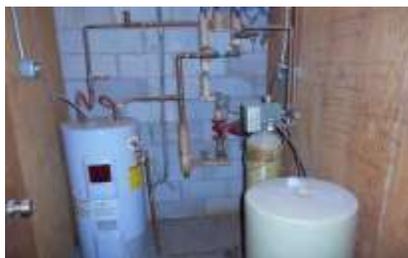
The water softener equipment is very old and did not appear to be functional.

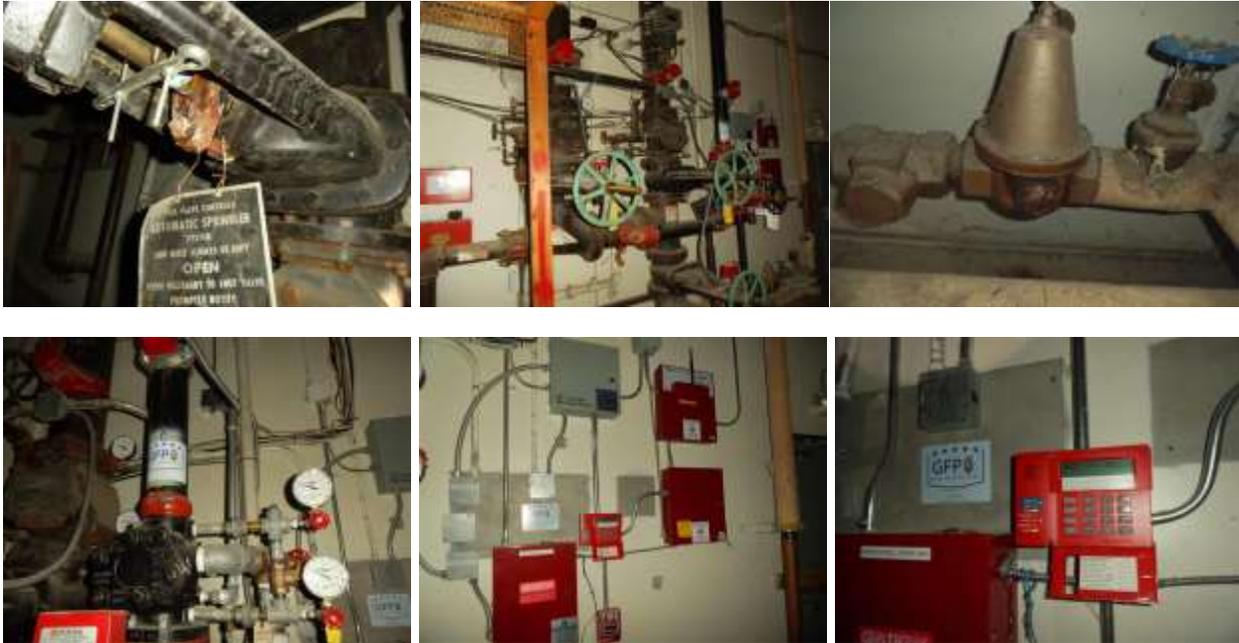
- Able Inspection Company does not inspect fire sprinkler systems. However, significant corrosion and at least one leak was observed at one of the main valves, and the pressure regulator(?) valve is also corroded. The alarm control pad shows a fault. This equipment should be examined and tested by a licensed fire sprinkler company. This fire sprinkler system serves other areas of this same strip center.

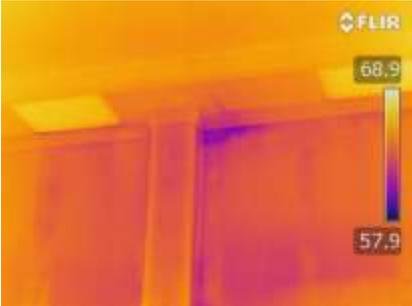
Water leakage in front east ceiling wall

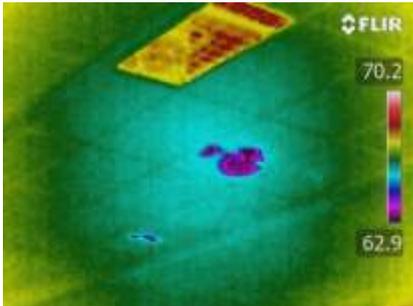
Water stained ceiling files

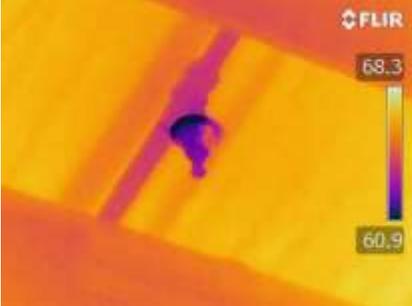
Leakage off fire sprinkler head

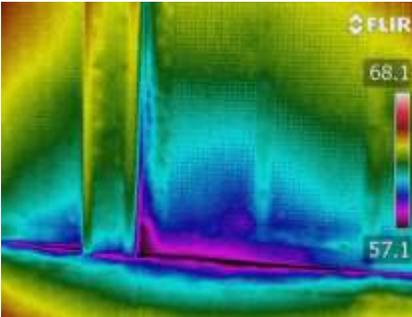
Water at base of front east wall

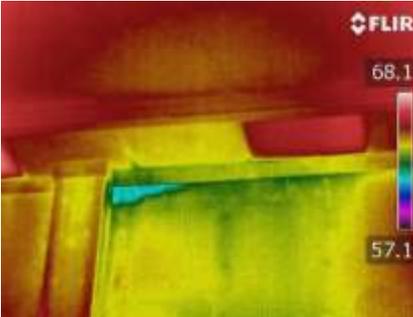
Water image in front east wall

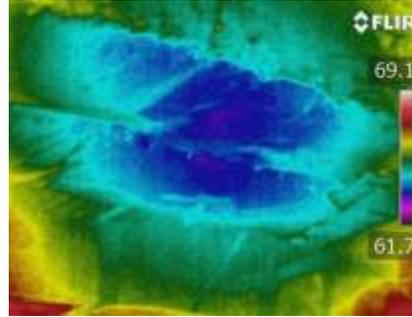
Water images off HVAC plenum

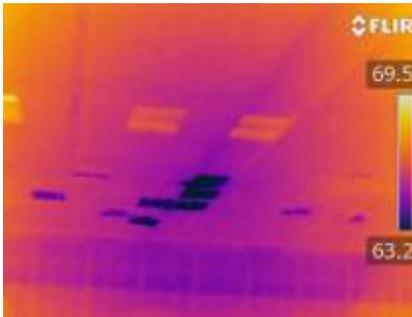
Water images on ceiling tiles from leaks

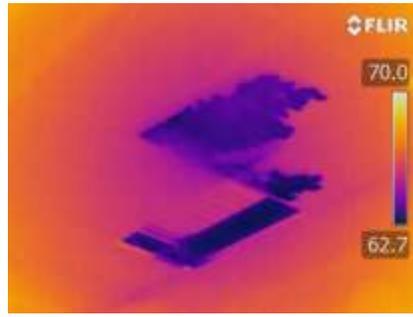
Water stained ceiling files

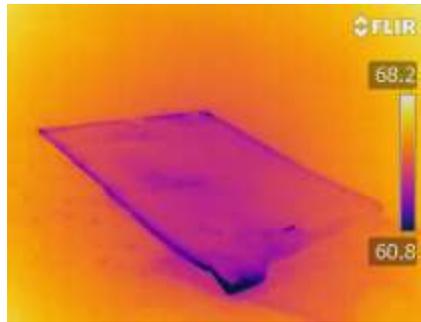
Wet ceiling tiles on floor

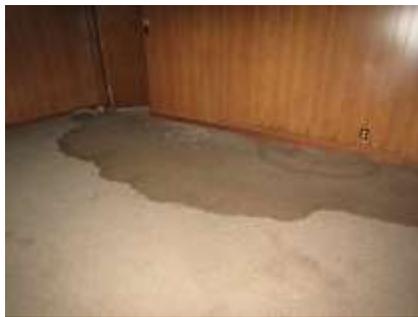
Second level carpet stains

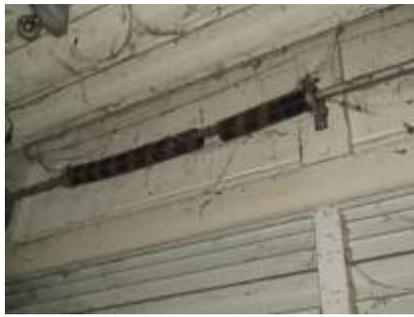
Broken bay door torsion spring

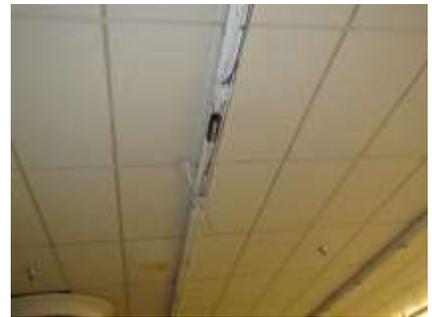
Broken lights

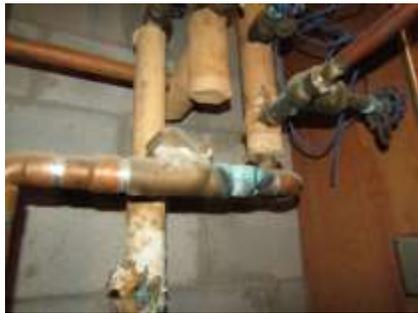
Corrosion on water piping in water heater closet

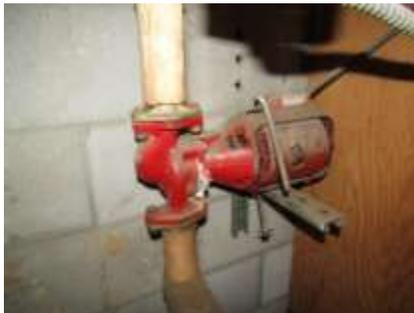
Corrosion on water pump from leaks

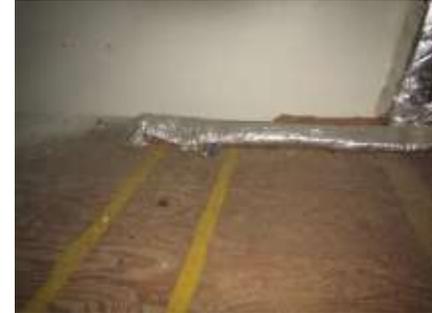
Damaged HVAC duct in second level

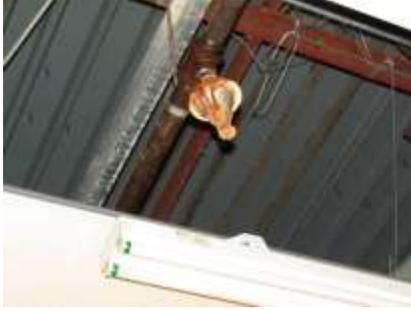
Fire sprinkler head leak

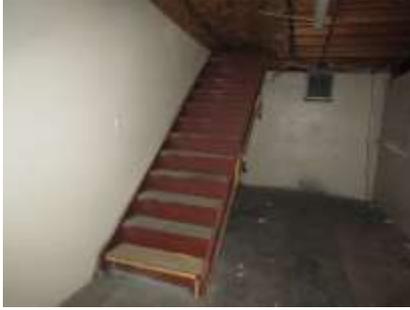
No railing and side rails in stairs

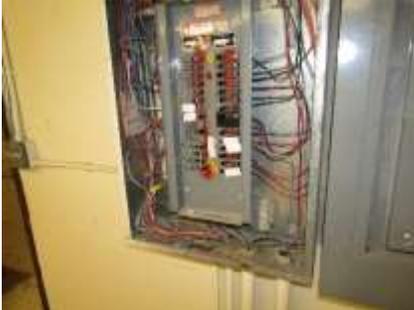
Panel cover removed

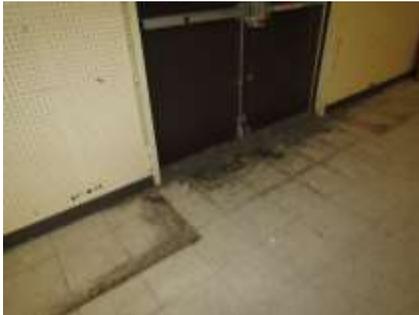
Stains and damages inside rear doors

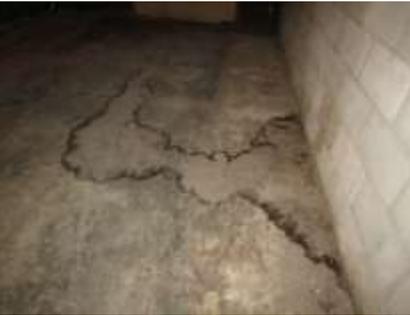
Stains at rear south wall

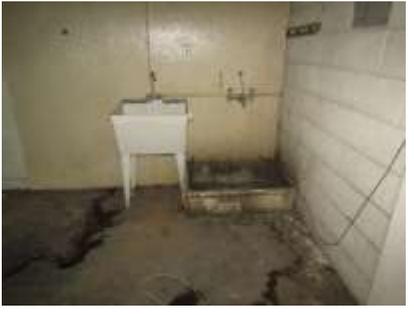
Stains in janitor station

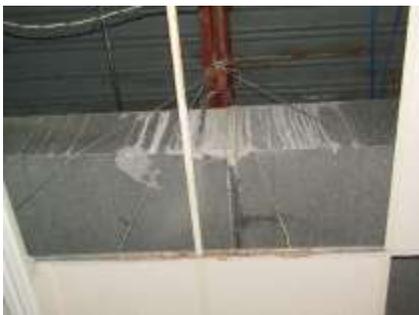
Stains off HVAC plenums from roof leakages

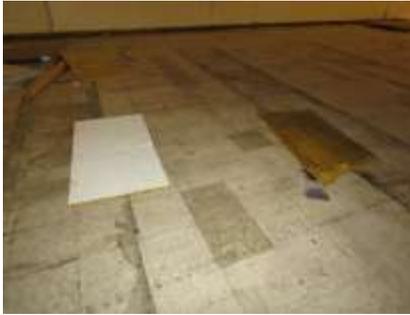
Wet ceiling tiles from roof leaks

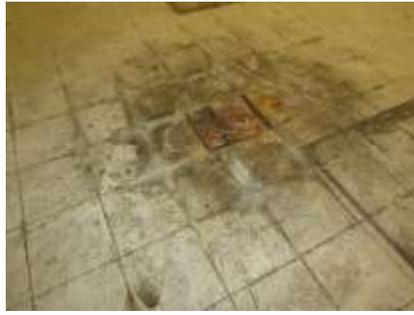
Active water on floor in Hobby Lobby

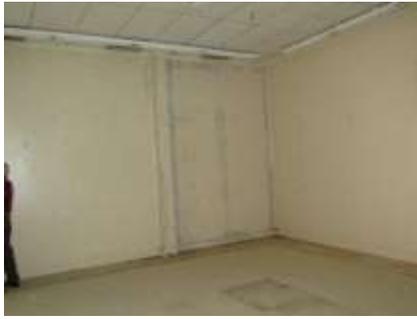
Water stains and active leakage in Hobby Lobby

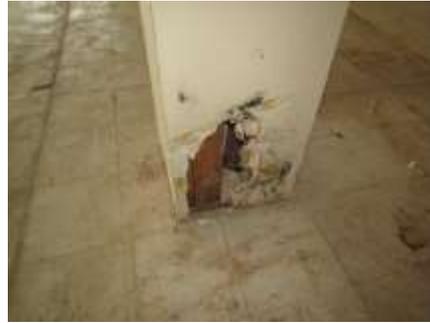
Water stains and mold on drywall in Hobby Lobby
