ABLE INSPECTIONS
Inspecting Office buildings
 Since 1976
 713 465-0000

PROPERTY INSPECTED:

INSPECTOR: Larry Malloy TREC 332

OFFICE BUILDING DESCRIPTION w/ATTACHED FRONT AND REAR ENTRY COVER

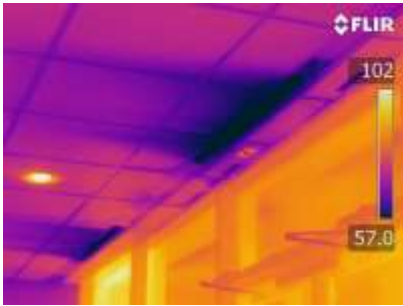
Quality air supply out of slotted air registers

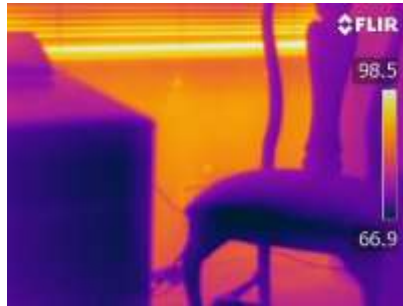
No anomalies under 1st level windows

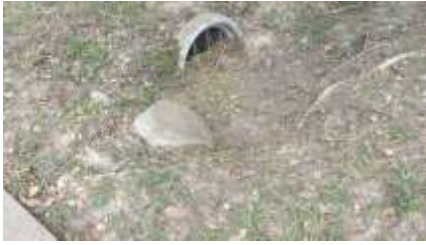
Clogged drain in culvert

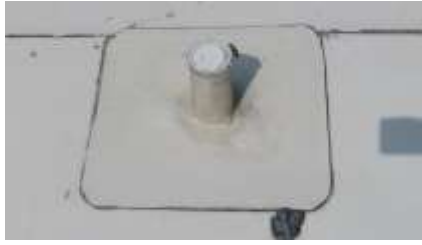
Capped drain waste vent on roof

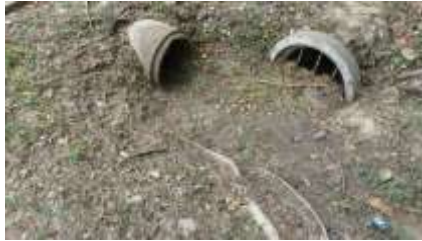
Debris and clogged drain culvert and pipes

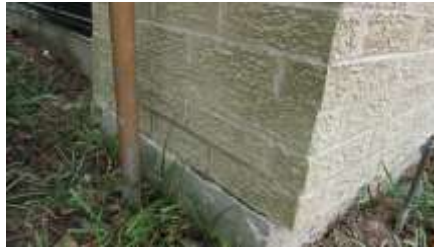
No weep holes at base of brick columns

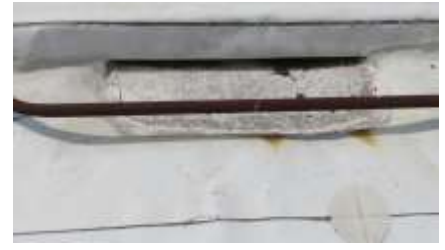
Narrow south drain scupper

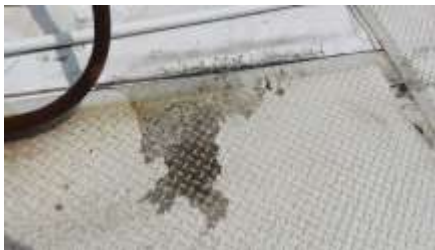
Water under mat around HVAC units
