ABLE INSPECTIONS
Inspecting Office buildings
 Since 1976
 713 465-0000

PROPERTY INSPECTED:

INSPECTOR: Larry Malloy TREC 332

OFFICE BUILDING DESCRIPTION w/ATTACHED FRONT AND REAR ENTRY COVER

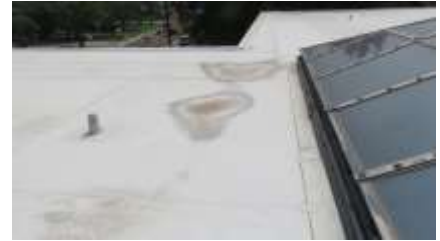
Dark area from ponding water
