**ABLE INSPECTION
COMPANY**
*Inspecting Homes Since
1976*
713 465-0000

PROPERTY INSPECTED:

INSPECTOR: Larry Malloy TREC 332

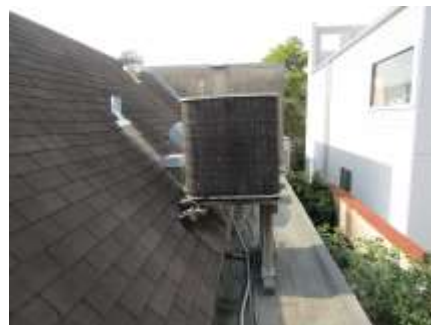
Abandoned A/C and wood frame

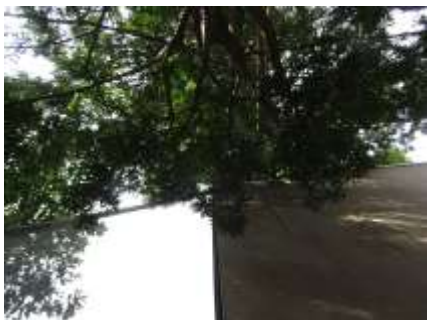
Tree branches on rear roof

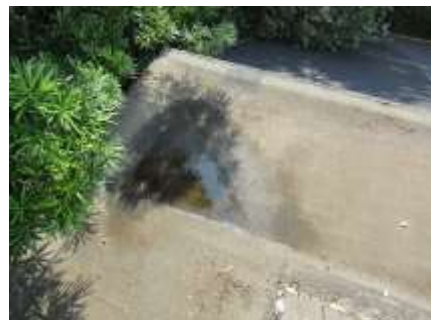
Ponding water on roof

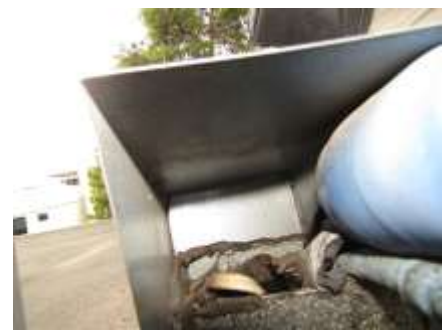
Void at guest quarters A/C roof jack

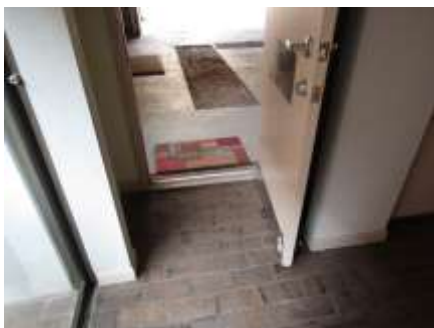
Door must be self-closing

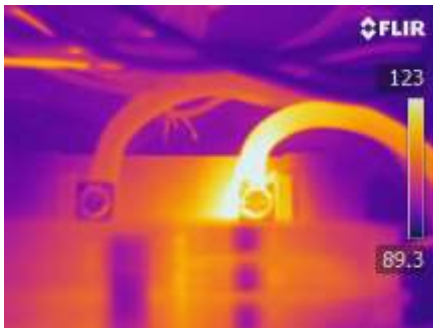
Heat image of 123 degrees on sub panel right feed leg

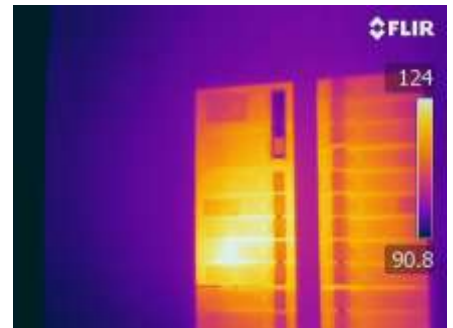
Heat images on house main panel breakers

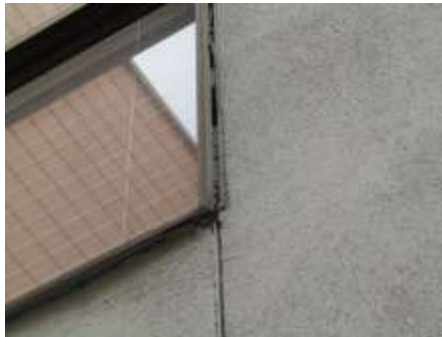
Poor sealant at windows

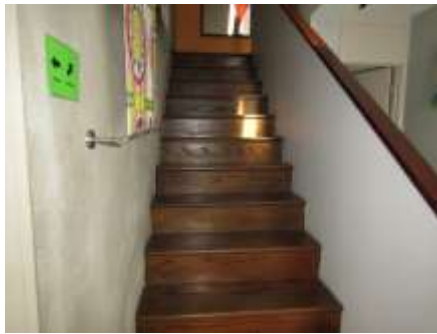
The steps (riser and tread ratio) in the stairs had a normal feeling when walked upon in a normal manner. **(D)** Handrails not installed in stairs of both house and guest quarters due to choice of architect/builder and greater than 4” openings exist at railing balusters in guest quarters.

No grippable handrail

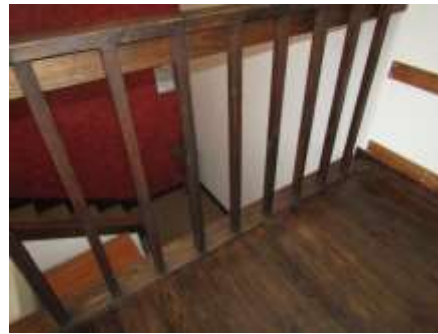
Large 4" opening at guest quarters rail

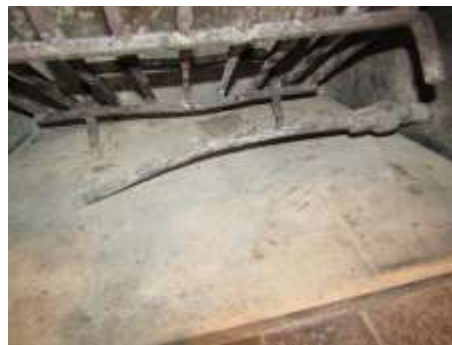
Bowed family room has starter pipe

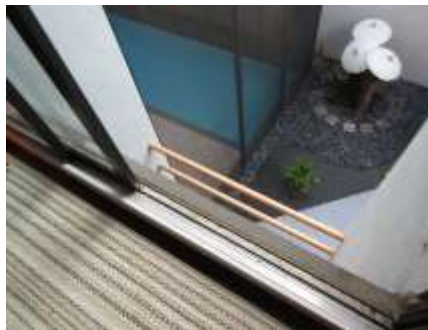
No deck at third level sliding door

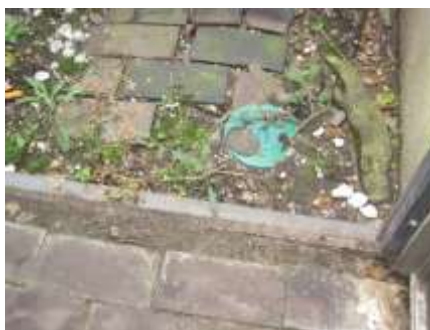
Subterranean termite bait station

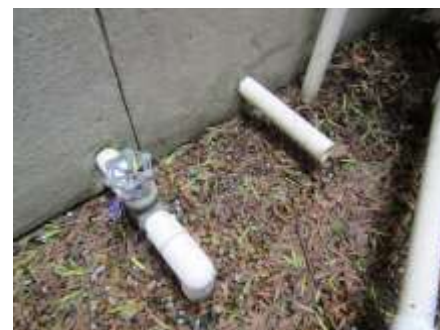
Old and abandoned rear PVC water piping

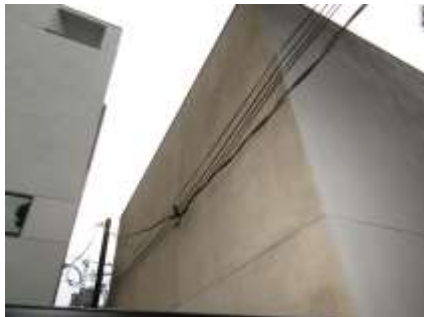
Wires on stucco wall

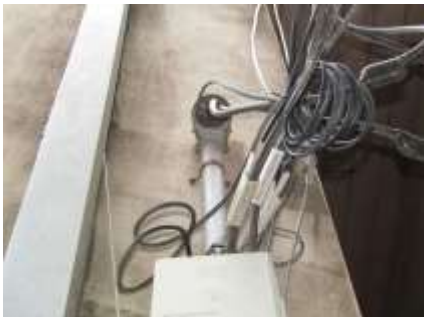
Utilities on mast pipe

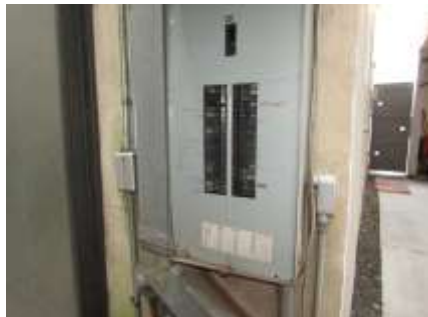
Poor labeling of breakers

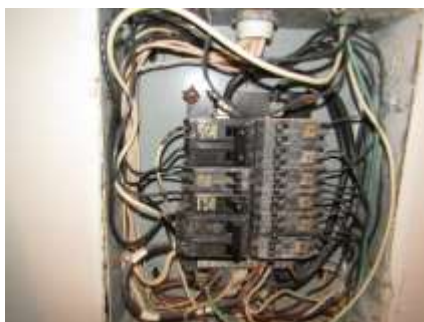
Hot right feed wire and on breaker at guest quarters panel

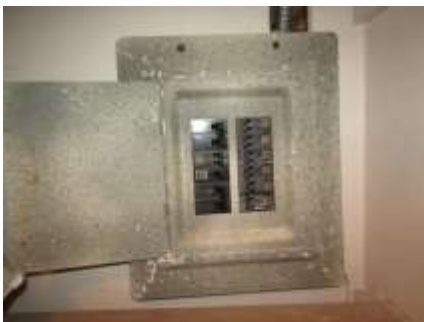
Guest quarters panel breakers not labeled

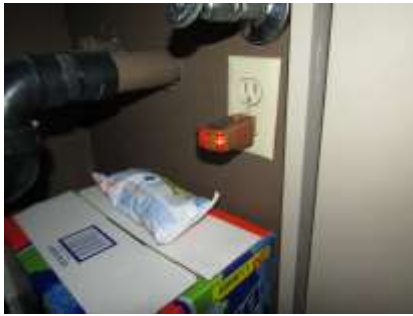
Not GFCI under wet bar

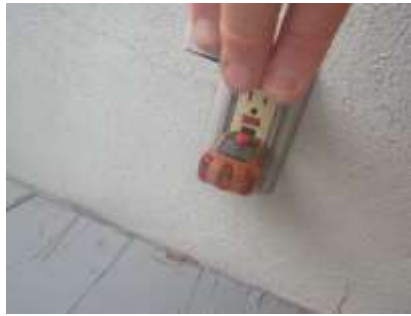
Front exterior GFCI not responding

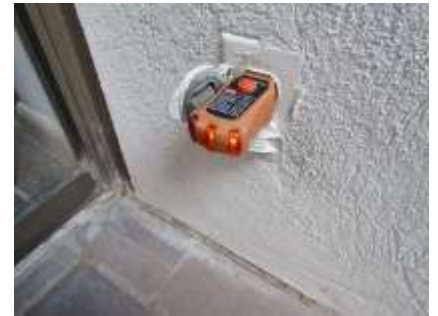
Exterior outlets not GFCI

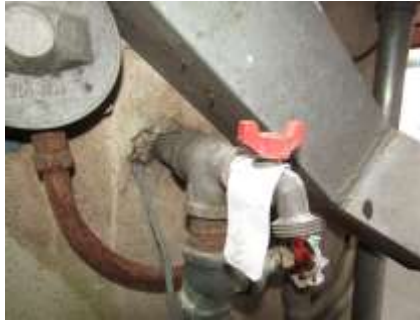
Rusted conduit

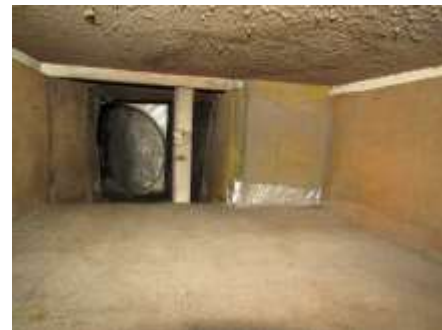
Clean and seal first level return chase

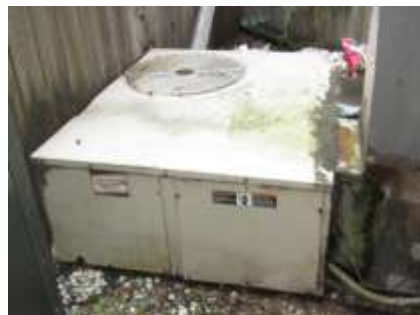
? Carrier, R22 refrigerant, packaged unit with out electric disconnect (first/second level west). **(D)** Clean coils on unit. This unit is in last stage of useful life and consideration should be taken to obtain proposals for replacement.

Old generation first/second level west unit

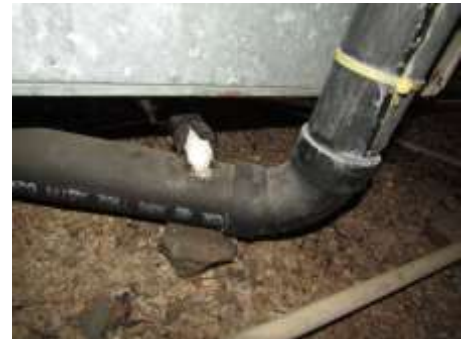
Primary drain in drain waste

Consult with HVAC contractor of your choice for the installation of available "union slip disconnect connection" on primary and emergency drains for service and maintenance. In addition, the necessary installation of "water level monitoring device" also on all drain line piping from coil.

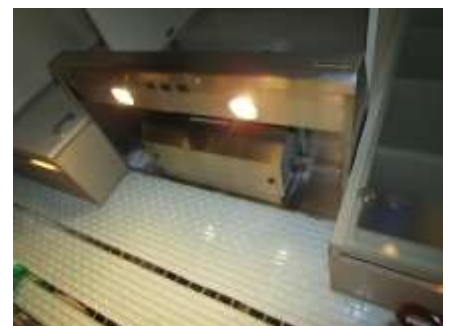
Vent A Hood overhead type. **(D)** Noisy operation of unit. Clean excess grease residue off of wheels. Unable to observe termination of this vent to the exterior.

Noisy overhead vent and greasy wheels

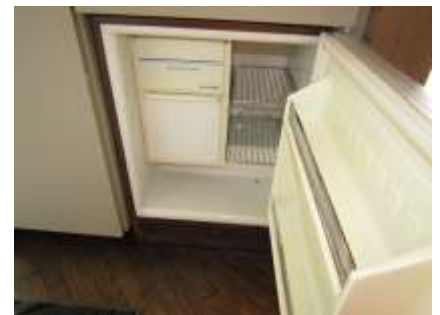
U Line type located in third level wet bar. **(D)** Not operative during inspection.

**Third level refrigerator not
operative**

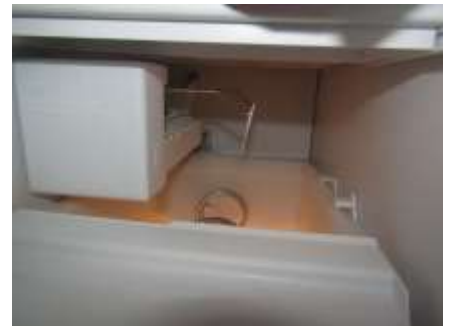
(D) No ice supply in bucket - this appliance is considered “as is”.

No ice in guest quarters ice bucket

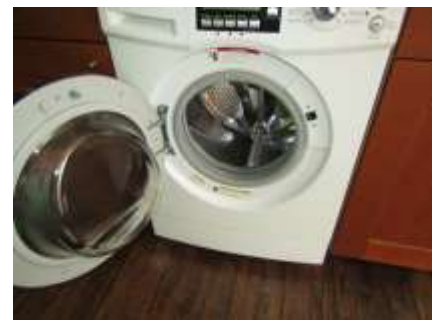
QUARTERS WASHING MACHINE: Edge Star type. **(D)** Unable to obtain operation of this appliance.

Washing machine not operative in guest quarters

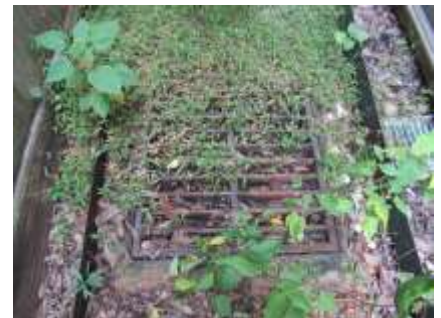
Sump pump. Apparent sump pump exists at northeast area of property, however, we could not remove metal cover to examine this pump for its integrity and suggest detailed information from seller on all service and maintenance and also have this unit examined further for its integrity.

Unknown function of sump pump

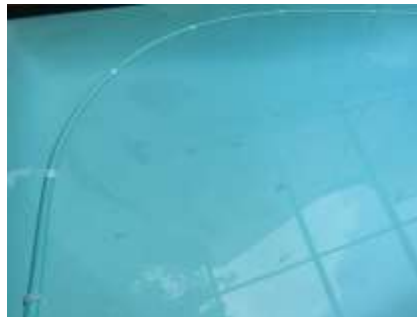
(D) Stained and discolored plaster with rough plaster finish and crack in pool off of steps.

Worn plaster
